BROADWAY BRIDGE RALL WHEEL STUDY

Client: CH2M Hill, Inc.

Owner: Multnomah County, OR

Broadway Bridge Rall Wheel Study

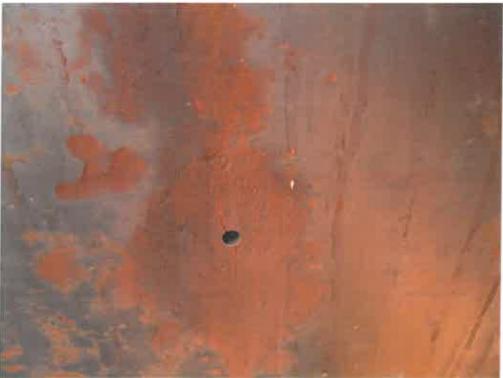
The contact surfaces of the wheels had some rusting, pitting and spalling (See photos M-002 & M-003). Several cored holes were observed. One cored hole was made through a crack in the surface (See photo M-004 & M-005). There was also a group of four cored holes at the upper left corner of the wheel (See photo M-006). On the wheel the visible signs of material differences were observed. These were generally surfaces areas that are inbetween areas where the wheel webs are. It was also observed that there are some areas where the material appeared to have lapped over. Most likely these are the areas where wheel repairs have been performed in the past (See photos M-007 through M-010). Two other cored holes were observed on the lower portion of the wheel surface (See M-011). A straight edge was placed across the width of a sample location of the wheel. The surface was found to be worn and wavy (See photos M-012 & M-013). The wheel rim was previously damaged and weld repaired (See photo M-022). During a bridge operation the wheel contact surface and rim/rim repair was observed (See photos M-015 & M-016).

M-004 NW wheel defect

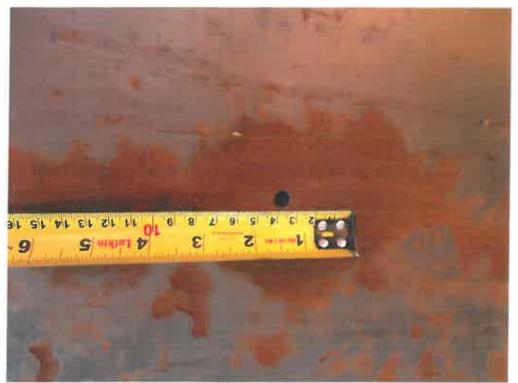
M-005 NW wheel defect

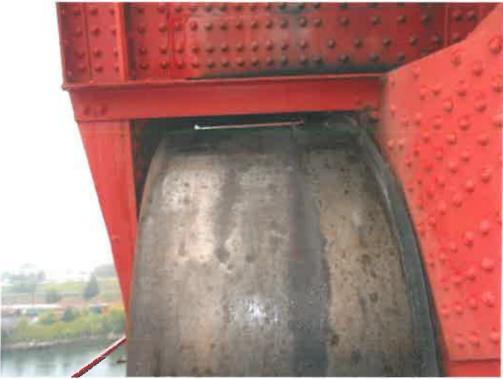
M-016 NW wheel rim defect (bridge open)

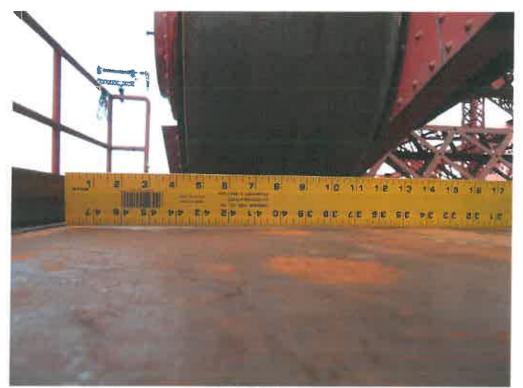
Generally the track contact surface condition matched the wheel surface. A straight edge was laid across the track. This surface was also found to be worn and wavy (See photo M-017). The surface of the track had many areas of rusting, pitting and spalling (See photo M-018). The North-West Track had a piece of rail added to the outboard side of the track. The purpose of the rail was most likely to help guide the wheel due to the previously damaged inboard wheel flange. Currently the rail has failed and separated from the track. It is most probable that the failure is the result of the wheel

M-018 NW track defect

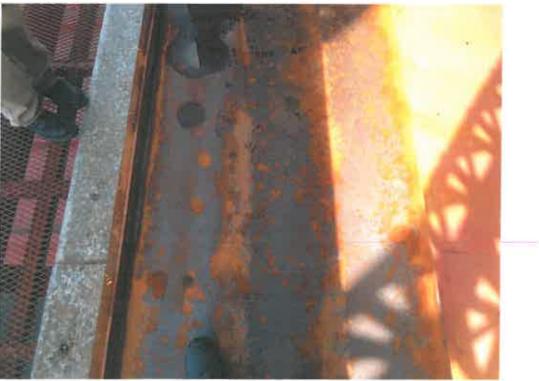
pressure/rubbing against the rail during operation. The majority (approximately 13ft of the total 17ft length of rail) of the weld that connected the rail to the track is cracked (See photos M-019 through M-022). It is noted that the wheel does not contact the rail during the initial travel from the closed position. The portion of track where the wheel sits when the bridge is in the closed position was observed during a bridge operation. No usual observations were noted (See photo M-023).

M-019 NW track defect

- Rall wheel operation and contact surfaces
- North-West track cracked rail
- Install survey monuments and monitor position (To rule out pier settlement as a cause)
- Operating Strut and Control Strut performance (Record any differences noted between the North & South on the West and the East leaves. Note any additional fastener failure)
- Anchor Strut performance (Record any live load bearing shoe differences noted between all four locations. Note any additional fastener failure)

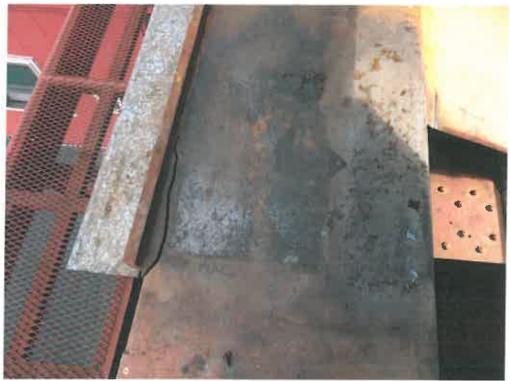
M-020 NW track defect, start

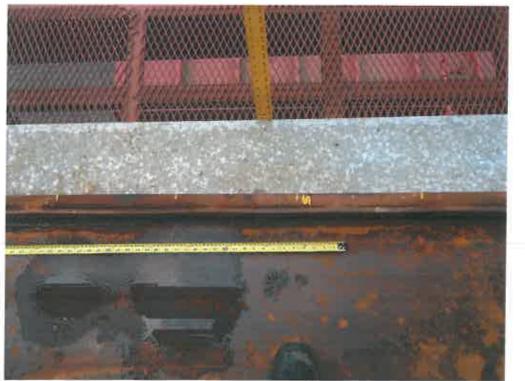
M-021 NW track defect, finish

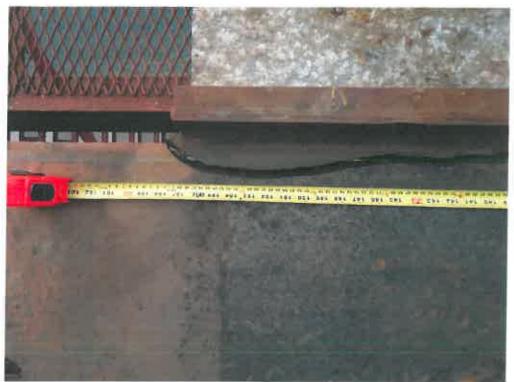
M-022 NW track defect

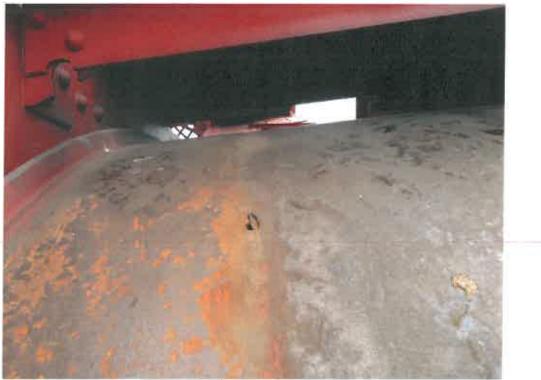
The contact surfaces of the wheels had some rusting, pitting and spalling (See photo M-025). A void/porosity defect was observed on the upper portion of the wheel (See photo M-026). One cored hole was observed on the lower wheel surface (See photo M-027 & M-028). A straight edge was placed across the width of a sample location of the wheel. The surface was found to be worn and wavy (See photo M-029). During a bridge operation the wheel contact surface and rim was observed. No unusual observations were noted (See photos M-030 & M-031).

M-028 SW wheel defect

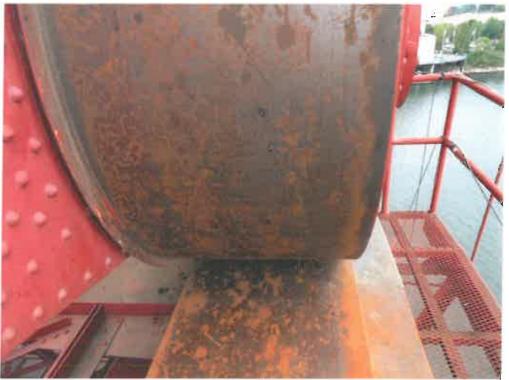
M-039 NE wheel defect

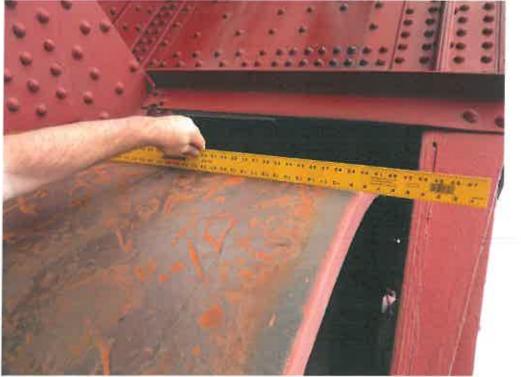
M-040 NE wheel defect

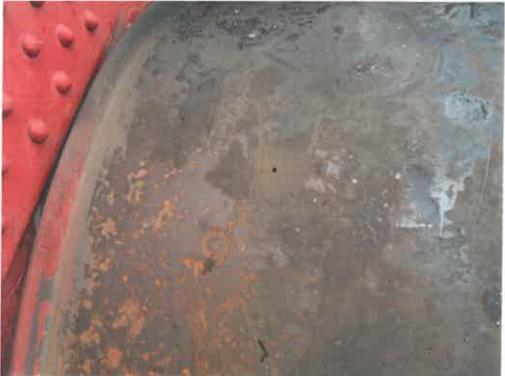
M-042 NE wheel defect (bridge open)

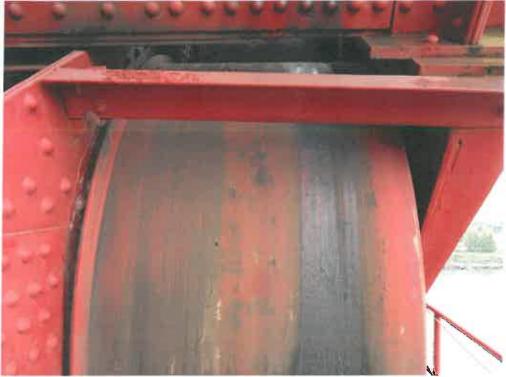
The contact surfaces of the wheels had some rusting, pitting and spalling. At this location there appeared to be more impressions of items left on the track during operation (See photo M-038). One cored hole was observed on the wheel surface level with the shaft (See photo M-039). A straight edge was placed across the width of a sample location of the wheel. The surface was found worn and wavy (See photo M-040). During a bridge operation the wheel contact surface and flange was observed. A cored hole was observed on the upper wheel surface as the bridged opens (See photos M-041 & M-042). It appears that washers were left at some time on the wheel/track contact surfaces making permanent impressions (See photo M-043). As the bridge reached the nearly open position another cored hole was observed (See photos M-044 & M-045).

M-045 NE wheel defect (bridge open)

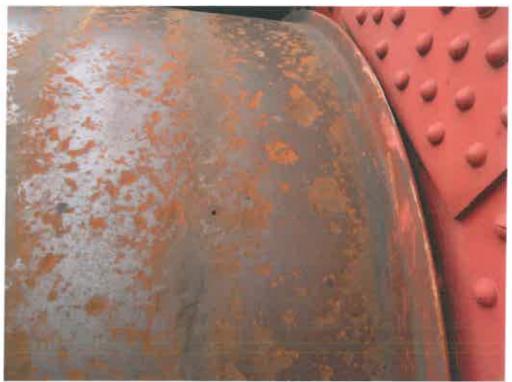
The contact surfaces of the wheels had some rusting, pitting and spalling (See photos M-049 & M-050). One cored hole was observed on the upper wheel surface along with a moderate impression (See photo M-051). A long impression was observed on the wheel surface level with the shaft (See photo M-052). During a bridge operation the wheel contact surface and flange was observed (See photo M-053). A cored hole was observed on the wheel surface as the bridged opens (See photos M-054 & M-055). As the bridge reached the nearly open position a moderate impression adjacent to the wheel flange was observed (See photo M-056).

M-051 SE wheel defect

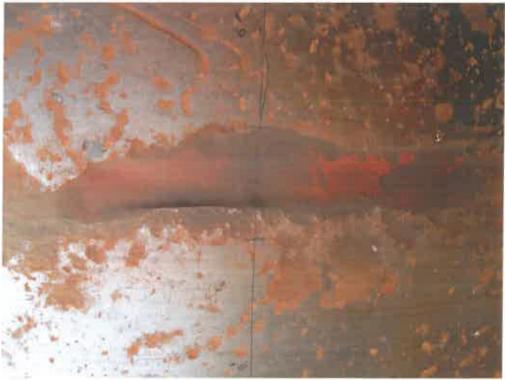
M-052 SE wheel defect

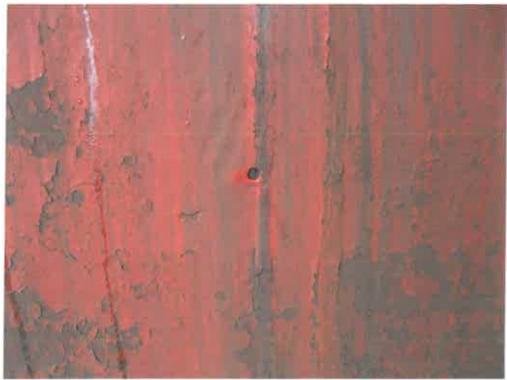
M-055 SE wheel defect (bridge open)

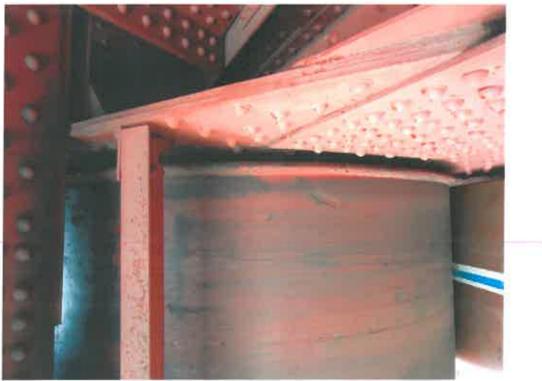
M-056 SE wheel defect (bridge open)

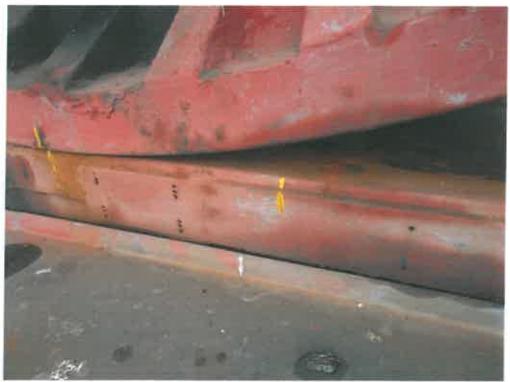
A straight edge was put across the track. This surface was also found worn and wavy (See photos M-057 & M-058). Approximately a foot away from where the bridge sits in the closed position a crack was observed on the track out board edge. The crack was approximately 2" long (See photos M-059 & M-060). Generally, the track contact surface condition matched the wheel surface (See photos M-061 & M-062). The portion of track where the wheel sits when the bridge is in the closed position was observed during a bridge operation. No usual observations were noted (See photo M-063).

M-059 SE track crack

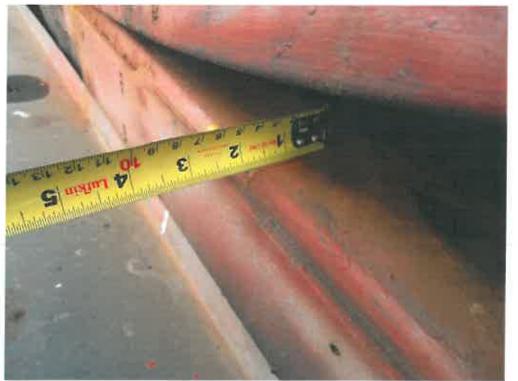
M-060 SE track crack

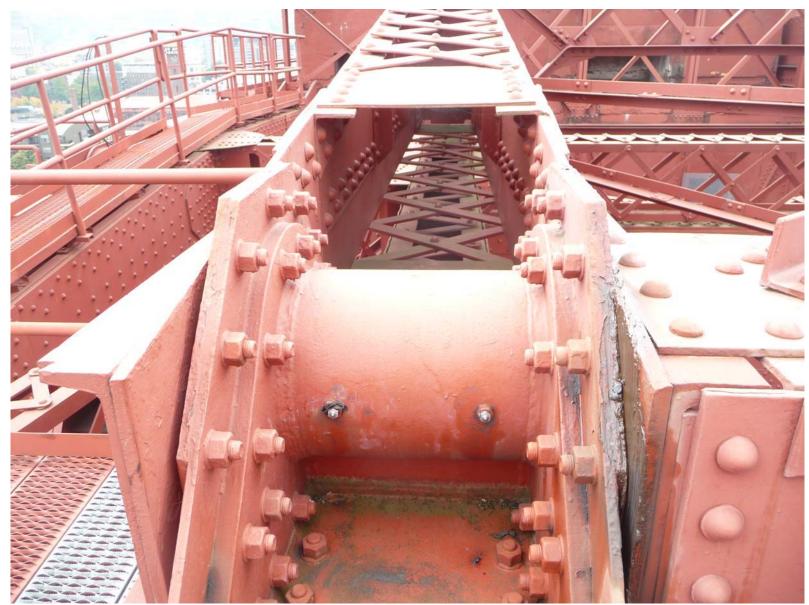
Figure 1 SW OP strut rubbing inboard side at pin. Note grease smeared on metal to metal wearing surface.

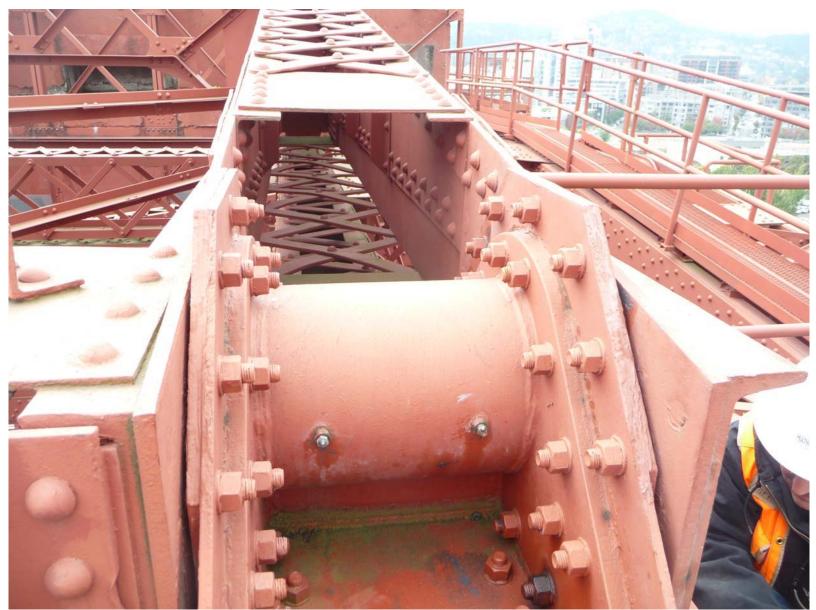
Figure 2 NW OP strut at pinned area 'not' showing rubbing like the SW strut.

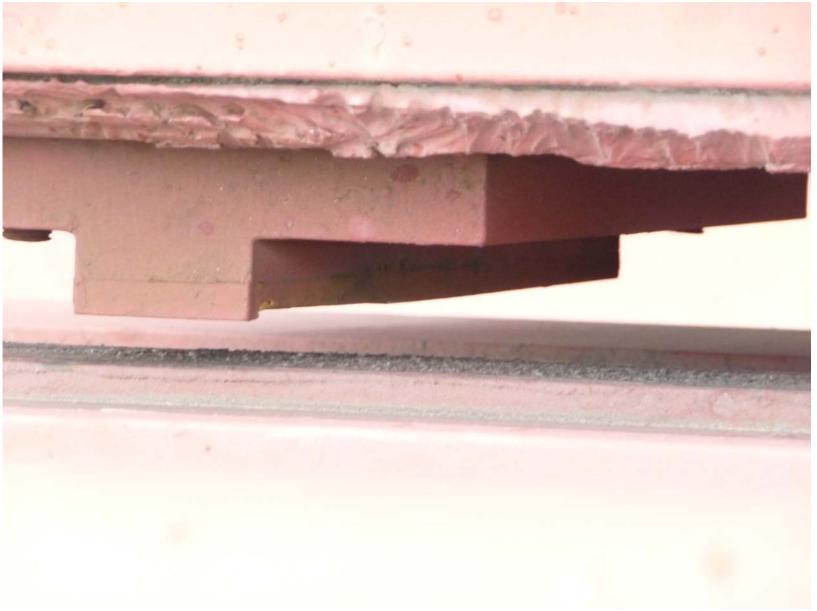
Figure 3 Typical wear on Anchor Strut rub block.

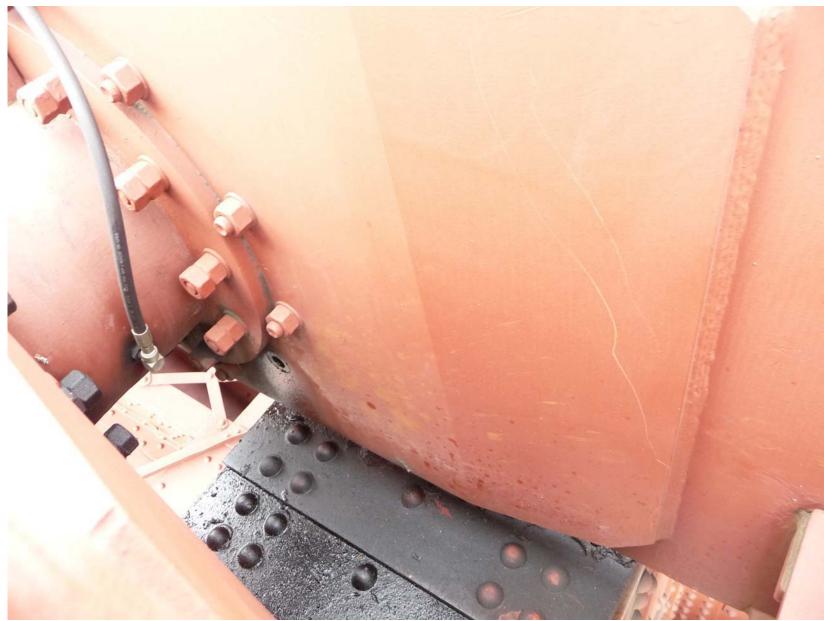
- In 2010, it was reported by the County that the South-West Rall wheel travels over 3" more that the North-West Rall wheel. Also it was found that the North-East Rall wheel travels 1" more than the South-East Rall wheel.
- In 2010, it was reported by the County that the South-West Rall wheel track is approximately 3/8" higher than the North-West track.
- County Personnel documented interference in the form of rubbing on the thrust face of the bearing at the operating strut fixed end connection on the West leaf. This is an indication that the operating struts are "twisting" or "racking" with respect to the leaf pulling unevenly at the Rall wheels during operation.
- County Personnel documented housing bolt failure at the anchor strut bearings (fixed end) on the East leaf.

Figure 4 Bolt failure location on Anchor Strut reinforcement plate near Anchor Strut pin.

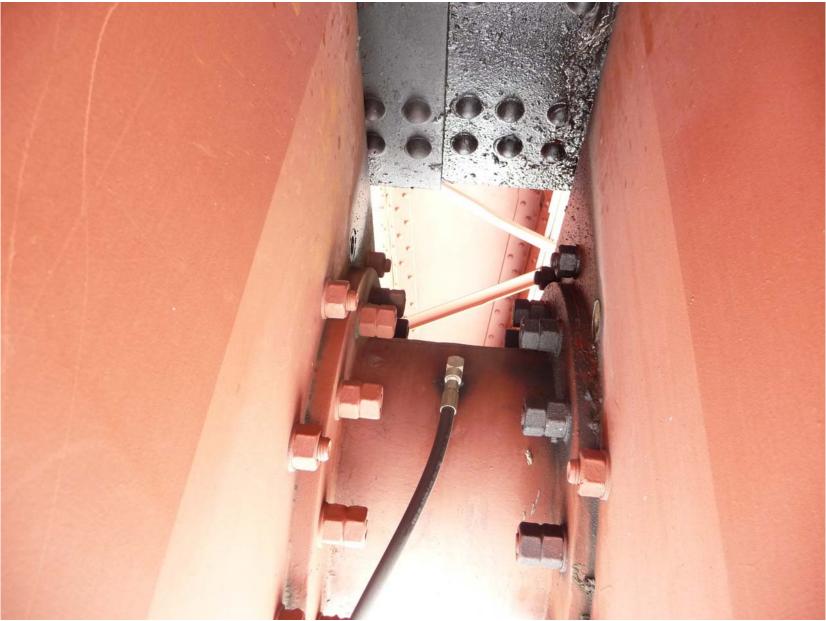
Figure 5 Another Anchor Strut view of locations where bolts broke near Anchor Strut pin.
