**PHASE I
ENVIRONMENTAL SITE ASSESSMENT**

**Wagstaff Battery
2124 N. Williams Street
Portland, Oregon**

May 24, 1992

TAG PN: 92112002

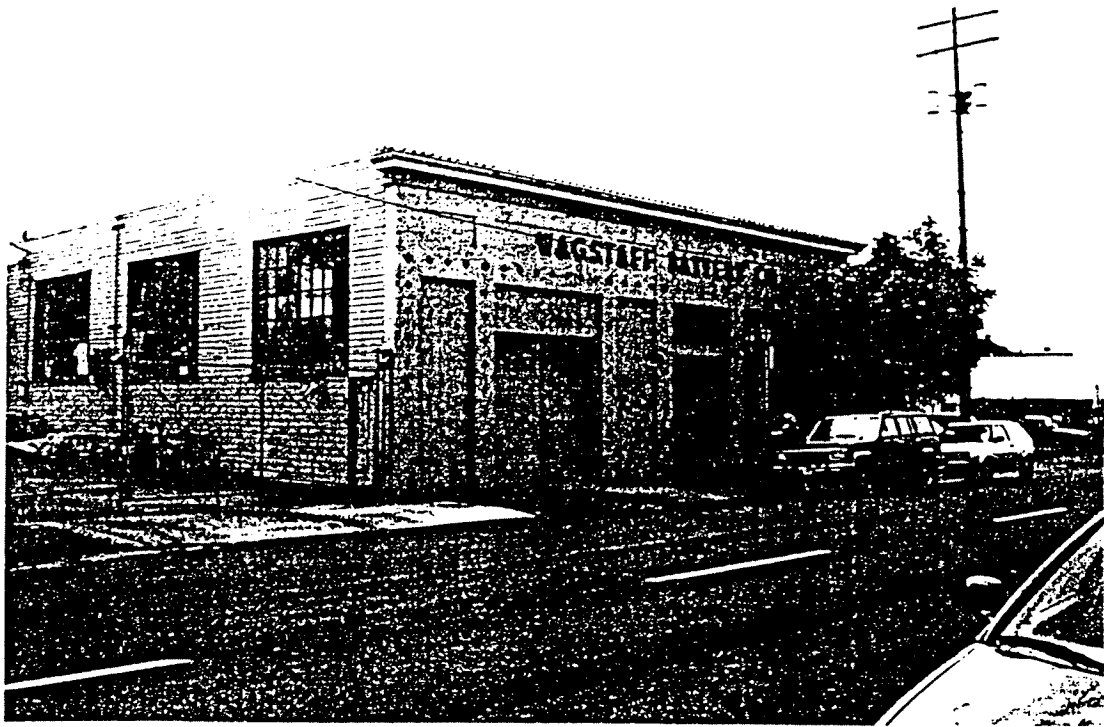
Photograph 1: Wagstaff Battery Manufacturing Company; View from northwest.

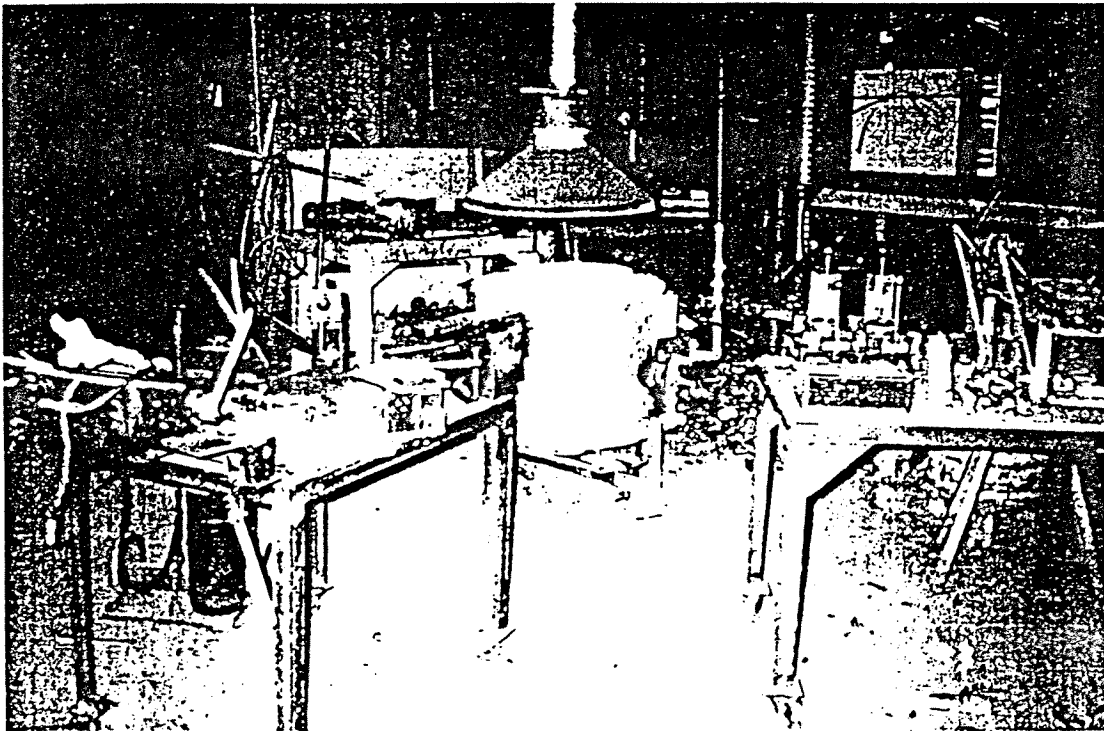
Photograph 2: Casting Room, Building I.

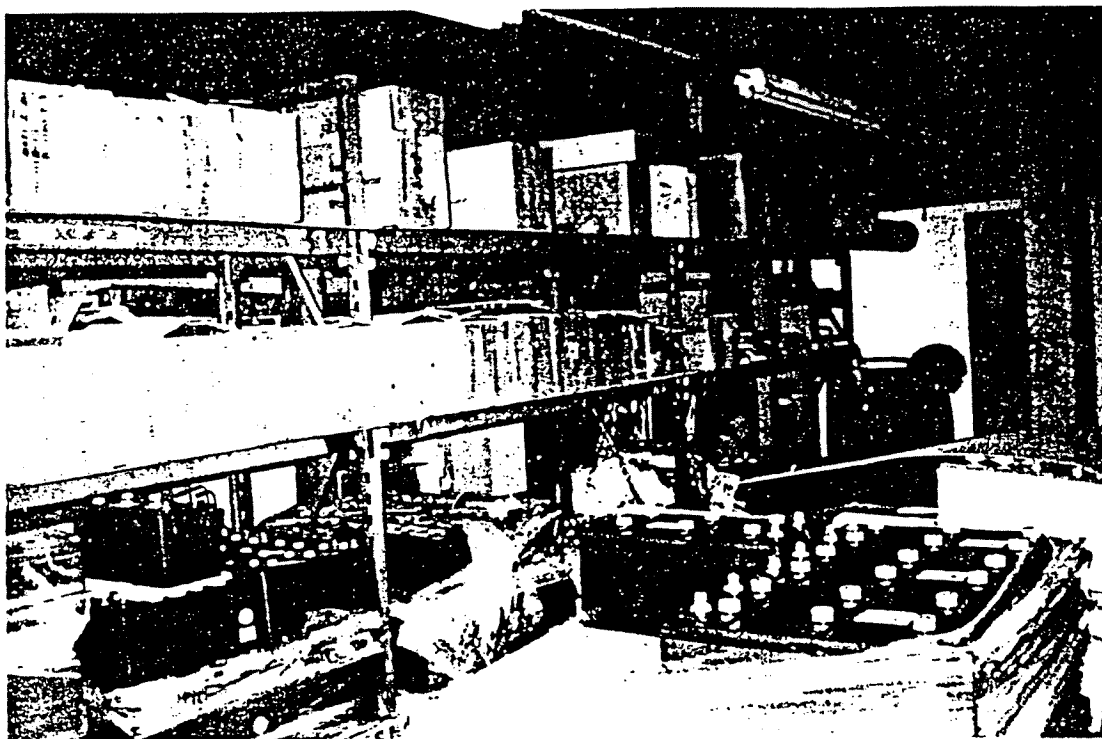
Photograph 7: Central Storage Area.

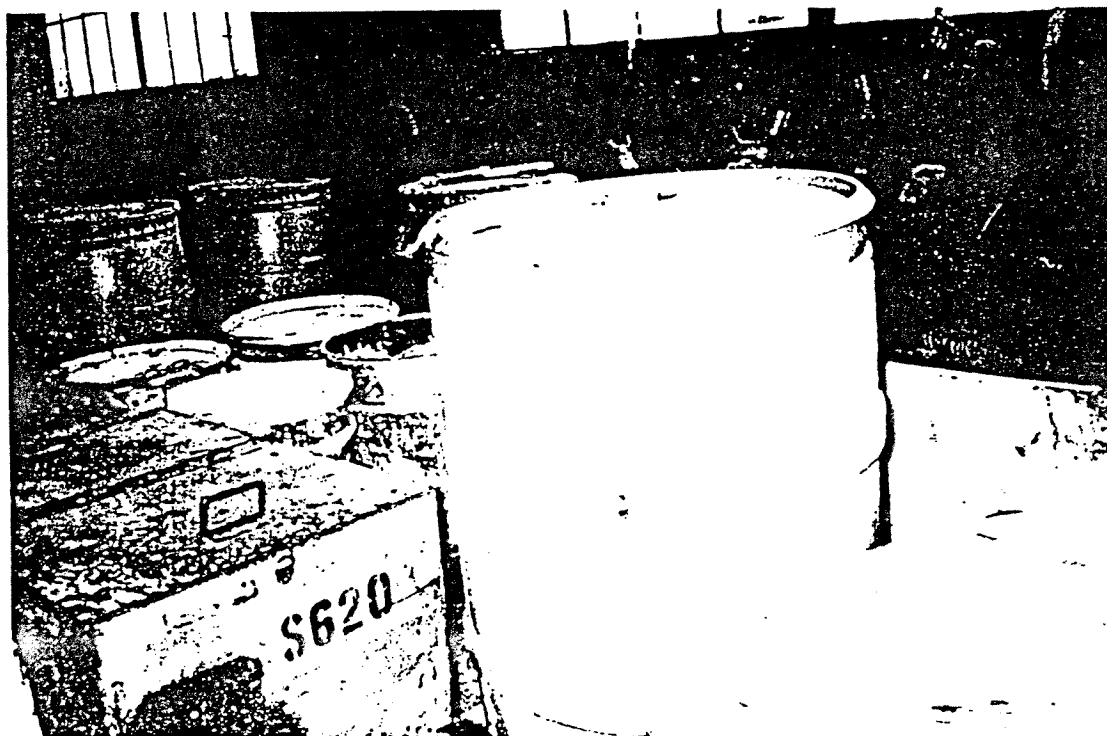
Photograph 8: Formation Room; Acid and Metal Storage Area.

- Subsurface soil samples should be collected from beneath the sump and separation tanks in Building I. Following removal of stored materials in the formation room, the floor should be examined for cracks and holes and other potential migration pathways to the subsurface. If such pathways are found to exist, subsurface soil samples should be collected from beneath those locations.

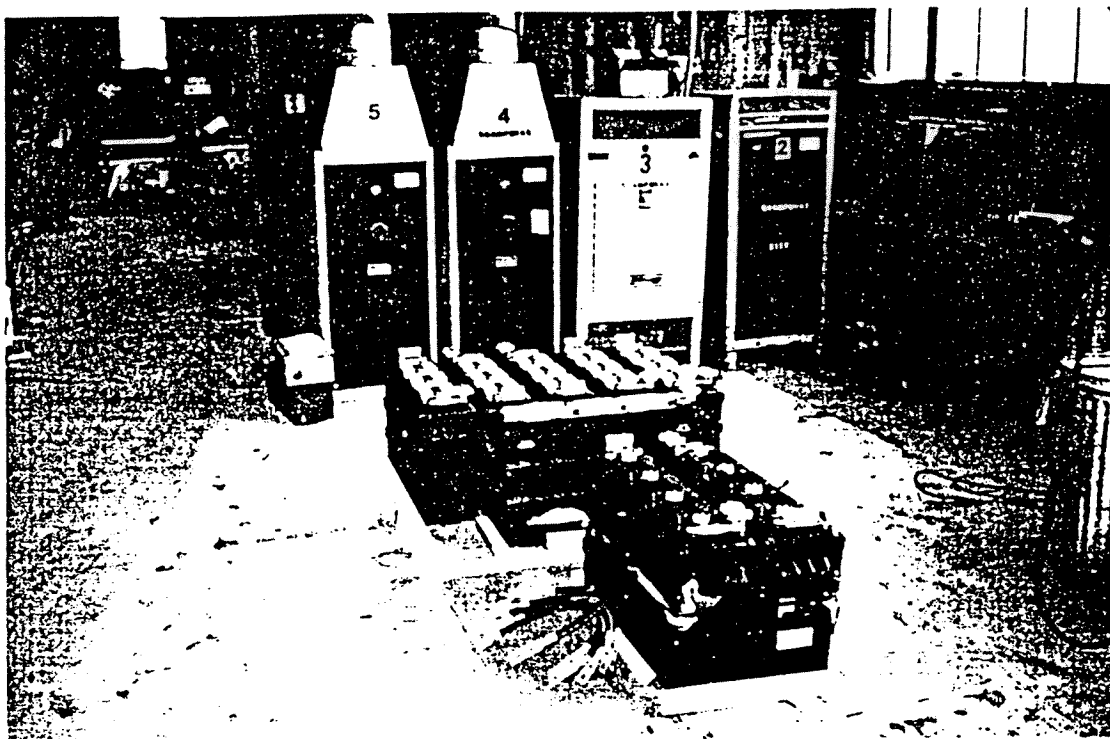
Photograph 9: NE Corner of Casting Room.

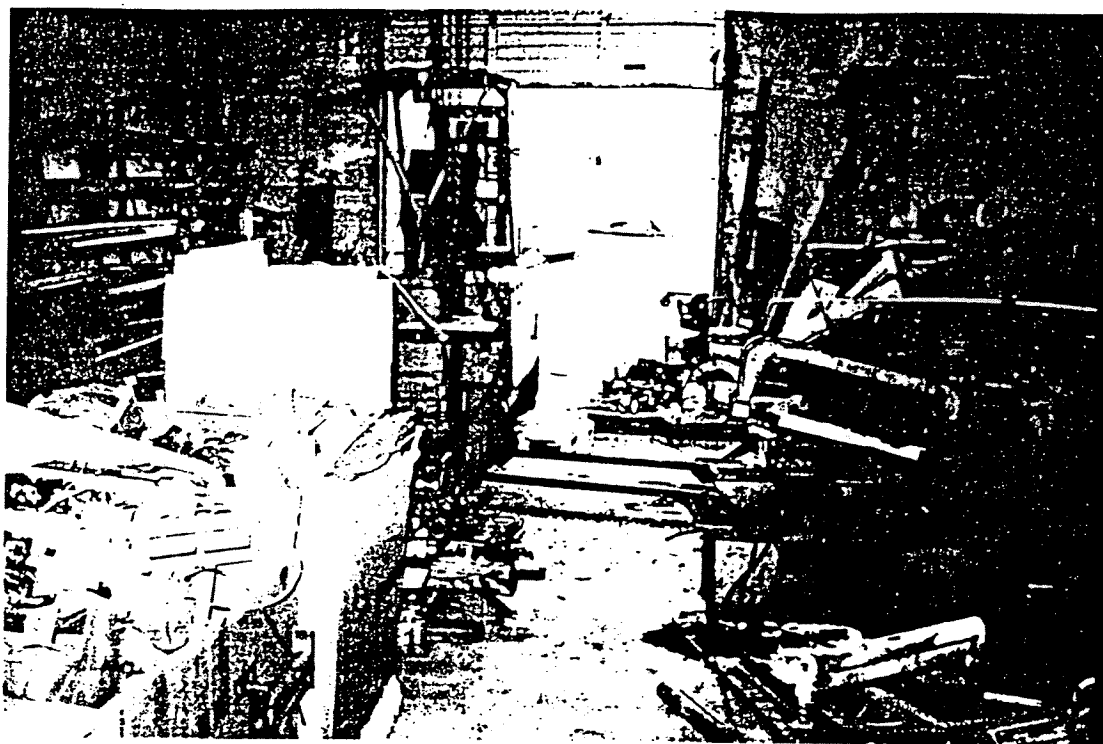
Photograph 13: Building II Machine Shop Interior.

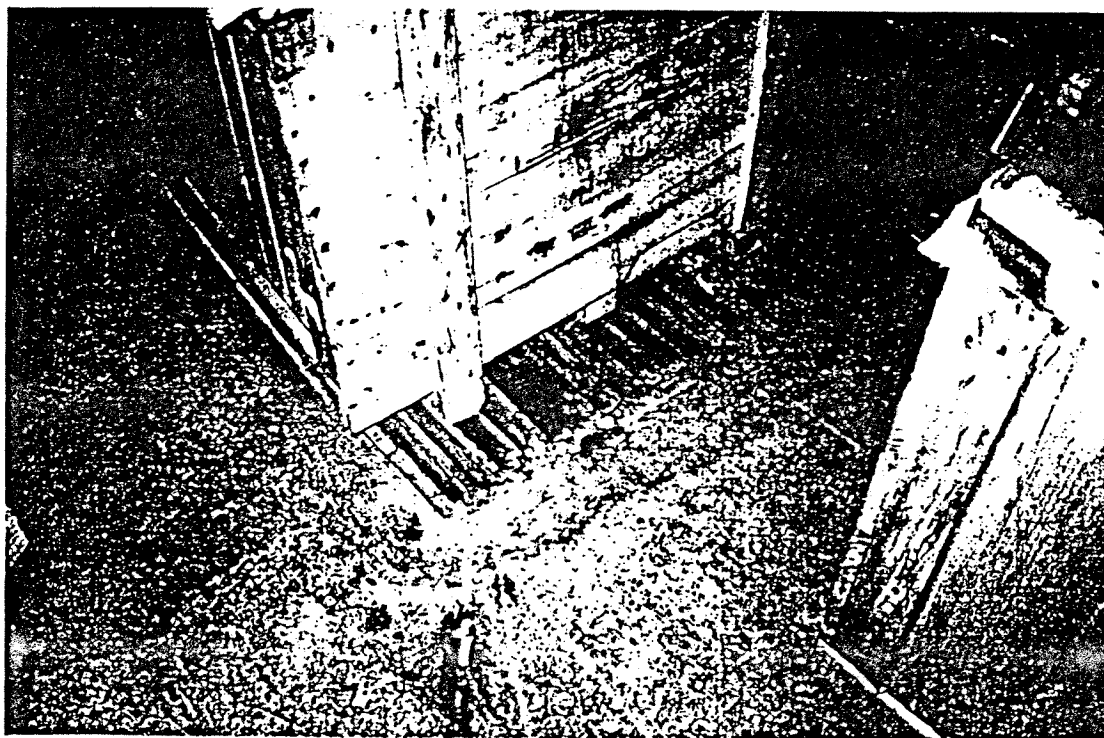
Photograph 14: Sump, Building II Floor..

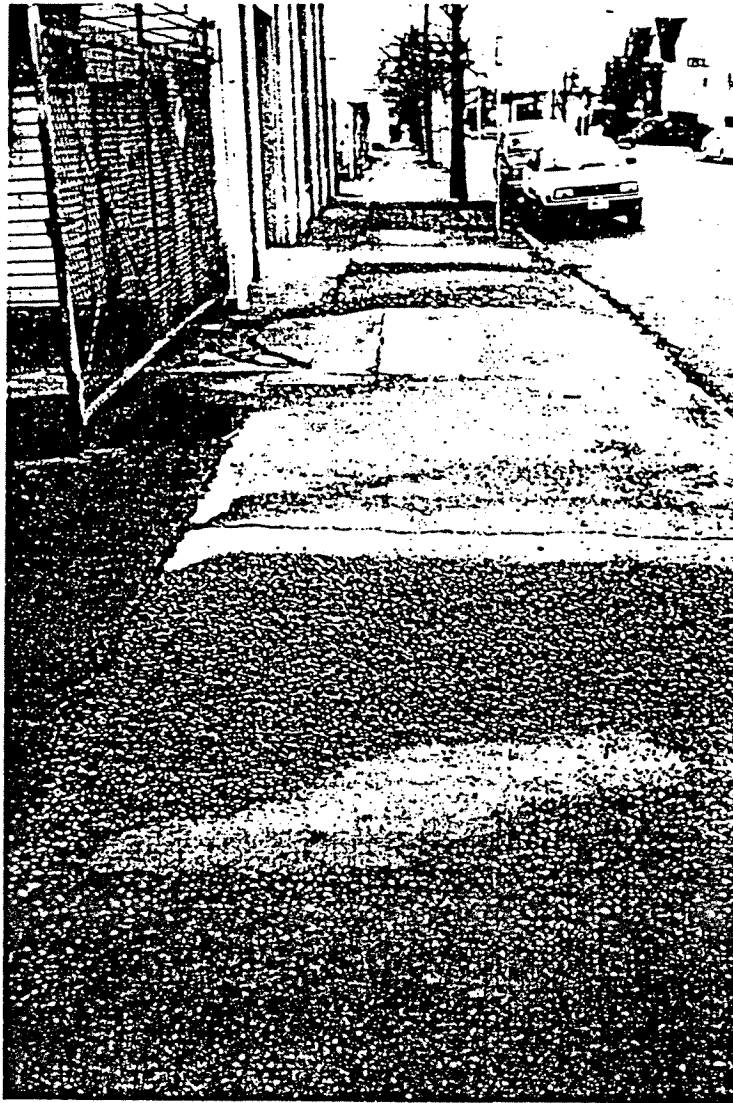
According to Doug Thompson (Director of Operations), waste water had been discharged to ground surface between the two buildings and allowed to run onto N. Williams Avenue. During the site inspection, the concrete sidewalk at this location was observed to have been etched so that the gravel aggregate was visible. According to Mr. Thompson, a portion of the area where the discharge occurred was not paved.

Photograph 15: Etched Concrete Sidewalk, N. Williams Avenue Property Boundary.

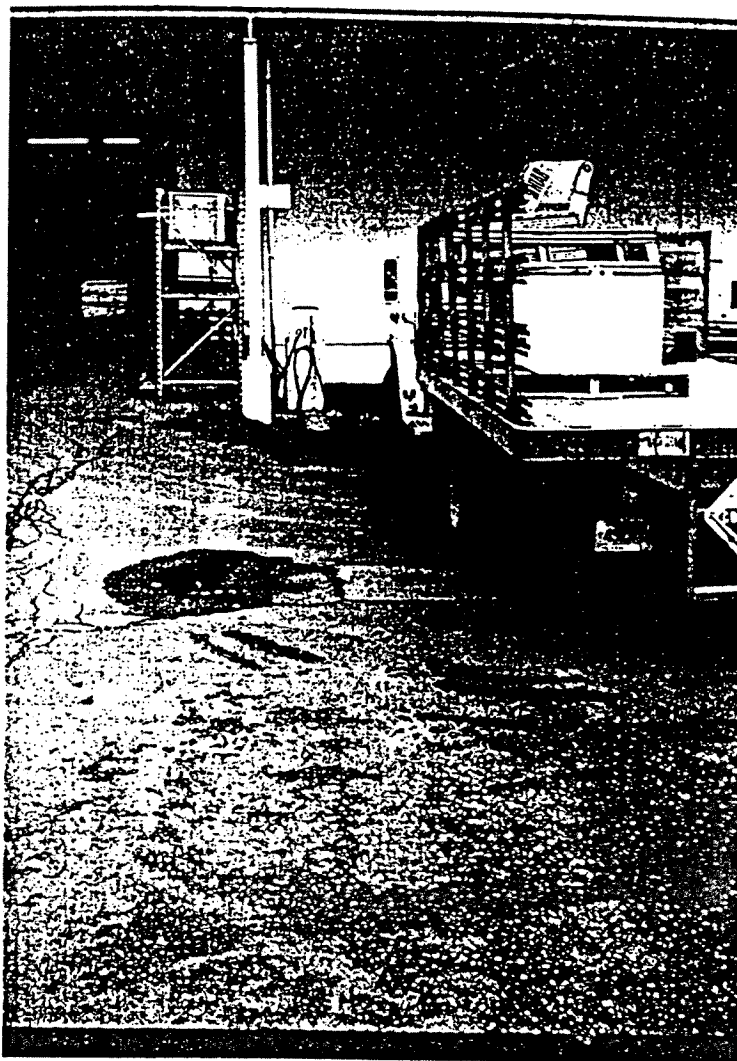
One 1,000-gallon underground storage tank (UST) is located on the property. This tank is registered with the DEQ, but is currently not in use.

Photograph 16: Gasoline UST Fill Port and Pump Location.
