Real-World Geotechnical Solutions
Investigation • Design • Construction Support

April 30, 2019
Project No. 19-5200

**RE: GEOTECHNICAL INVESTIGATION & LANDSLIDE HAZARD STUDY
WAIBLINGER HOMESITE
13195 NW MCNAMEE ROAD
MULTNOMAH COUNTY, OREGON**

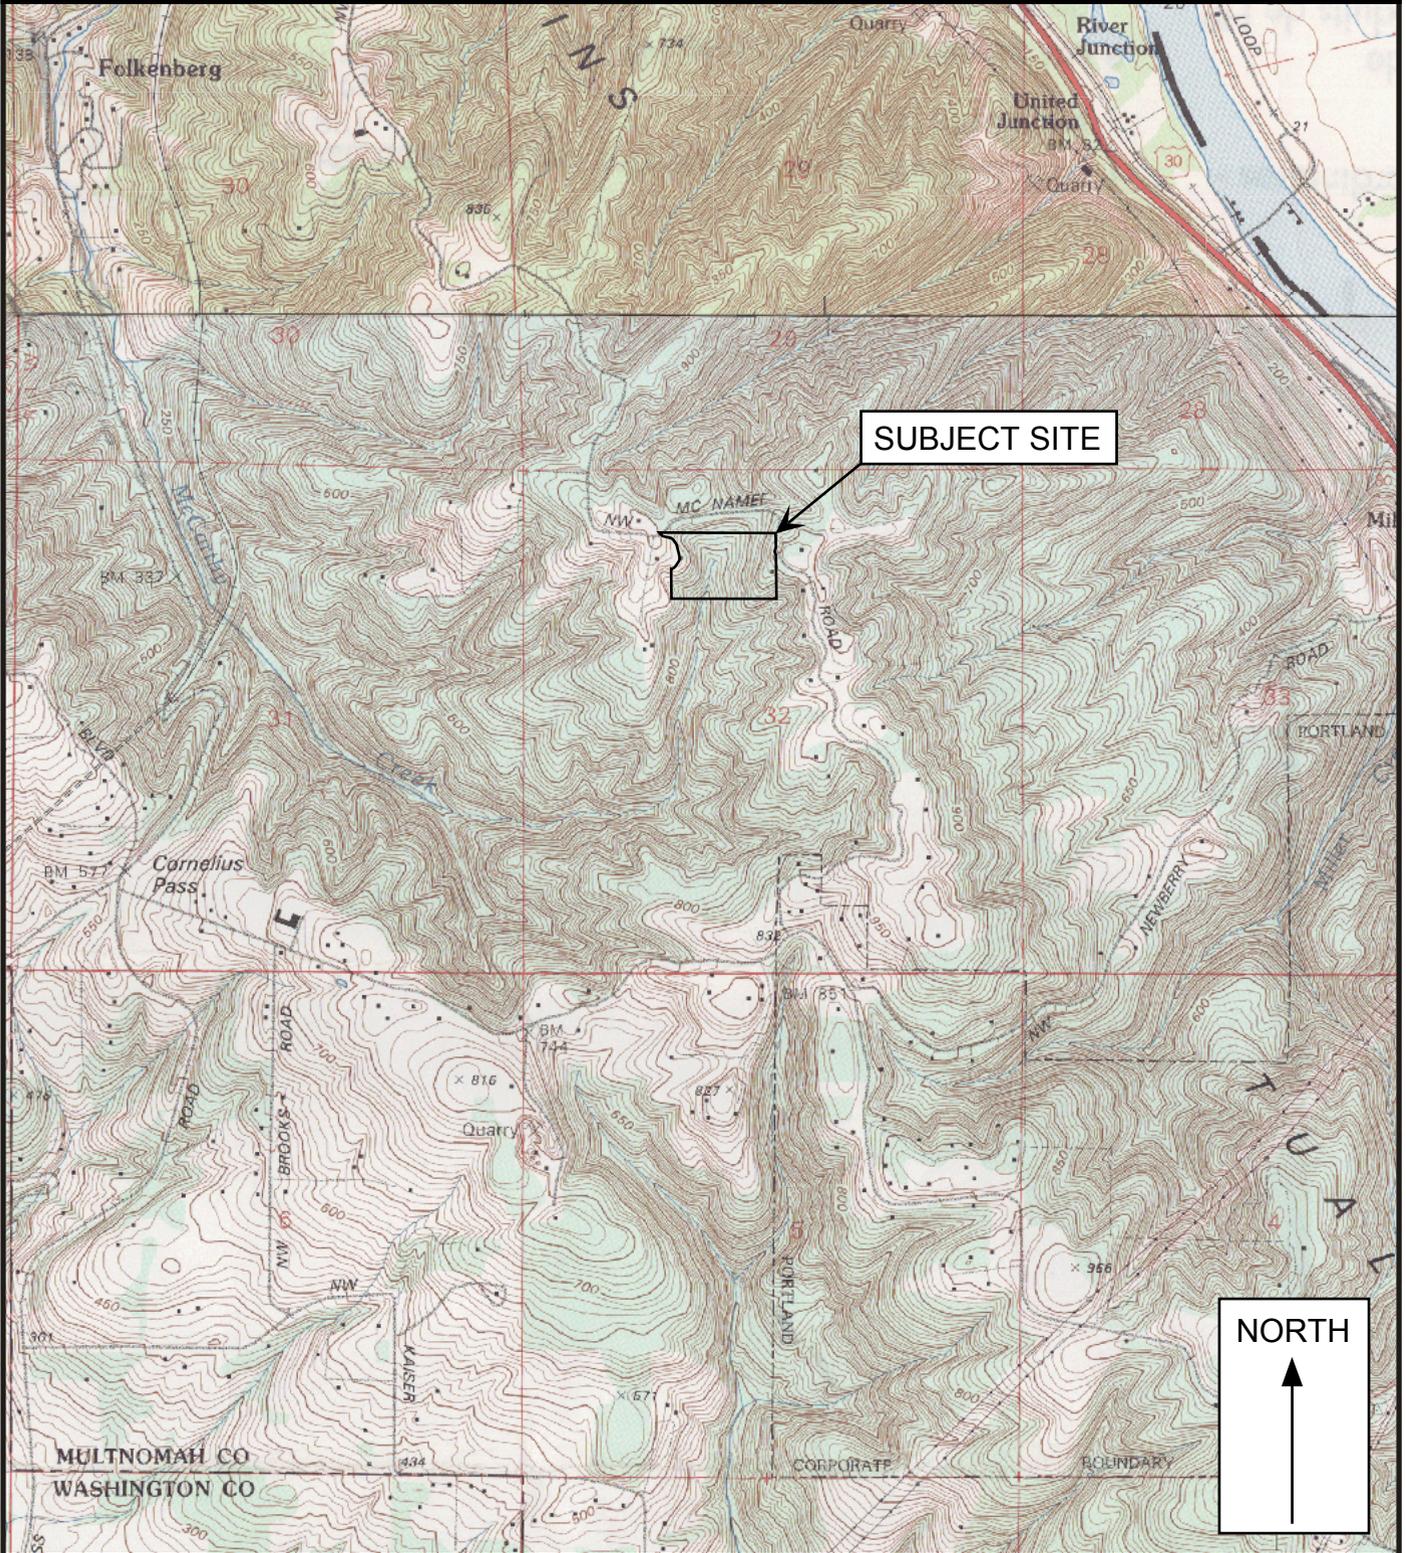
FIGURE 1A

Our review 1:24,000 scale topographic mapping by the U.S. Geological Survey indicate that the vicinity topography is smooth and uniform, consistent with relatively stable slope conditions. Our review of Lidar based high resolution digital elevation maps depict smooth topography in the vicinity of the proposed home, as indicated on Figure 2 (Dogami, 2019). The statewide landslide database and available landslide inventory mapping indicate two mapped landslides are present on the subject lot, as presented on Figure 2 (Burns et al, 2011; SLIDO, 2019). Both slides are classified as earth flow type landslides that are shallow and historic with movement within the last 150 years (Burns et al, 2011; SLIDO, 2019). The northern earthflow is the slope repair that occurred in 2010. Additionally, a prehistoric (>150 years old) debris flow is mapped adjacent to the incised drainage gully located approximately 500 feet to the west of the proposed homesite (Burns et al, 2011; SLIDO, 2019) as shown on Figure 1B. Several other historic and prehistoric earthflow type landslides are mapped along the McCarthy Creek drainage located southwest of the site (SLIDO, 2019). Seismic slope instability hazard mapping identifies the site vicinity as being in a low relative slope instability hazard zone based primarily on slope steepness (Mabey et al., 1996).

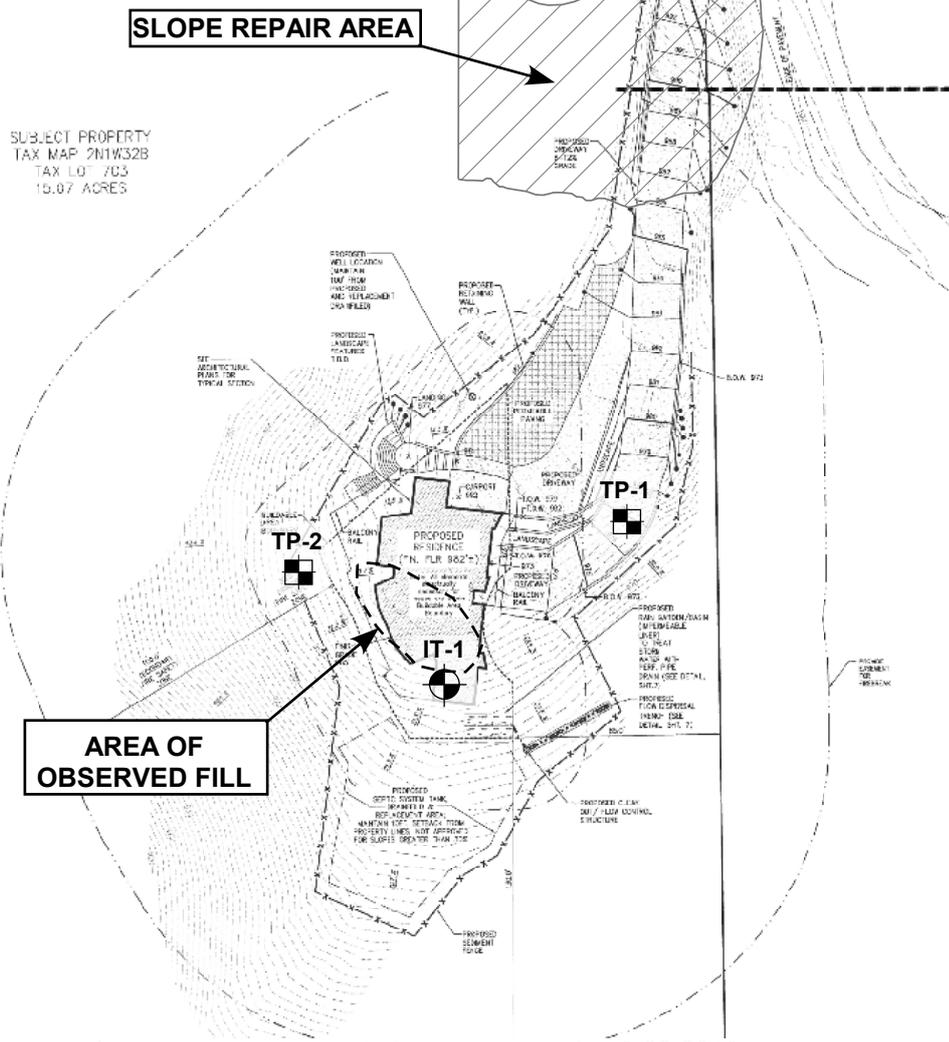
Undocumented Fill: Undocumented fill was not encountered in our explorations conducted for this study; however, an area of fill was observed during our reconnaissance. The approximate location of this fill area is presented on Figure 2. Other areas of fill may be present outside our exploration locations and should be encountered along the existing driveway alignment – in the vicinity of the prior slope repair.

Topographic mapping indicates that the proposed building site is situated on a gently sloping ridge with grades of approximately 8 to 25 percent (Figure 2) at elevations of approximately 968 to 980 feet above mean sea level (Figure 1A). Slopes adjacent to the ridge are on the order of 24 to 46 percent.
