## **EXHIBIT 16**

## Site Visit Report 645 SE Pounder Rd - March 1, 2021

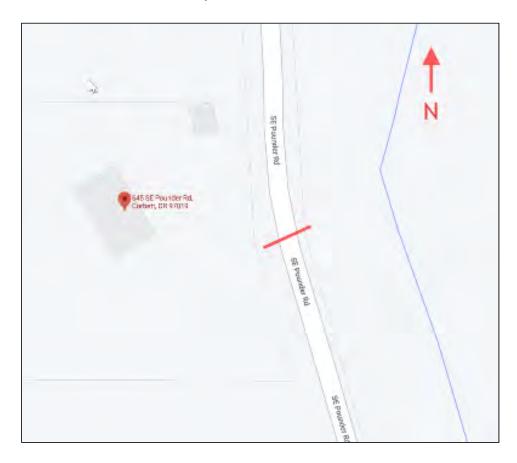
The roadway embankment on the east side of Pounder Rd near 645 SE Pounder has failed and slid towards Pounder Creek, destabilizing the east half of the roadway. The pavement in this section of roadway is visibly depressed with alligator cracking present adjacent to the failed slope. The slope failure is a result of oversaturation of the roadbed that was caused by at least partial blockage of the County's culvert, which carries water runoff from the uphill slope on the west side of the roadway to Pounder Creek on the east side of the road.

Emily and I went out to Pounder Rd this morning to look at the damage and decide what we need from an Engineering Consultant to allow us to repair the failed roadway embankment and culvert.

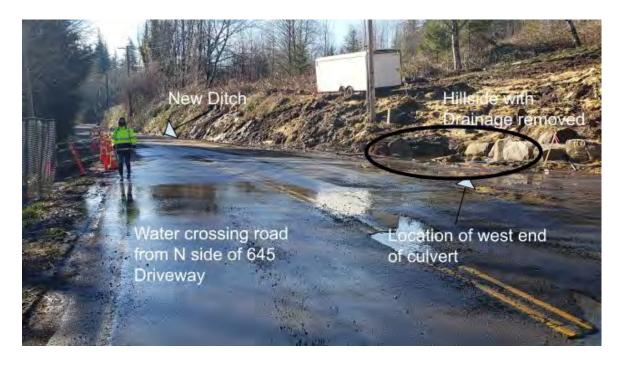
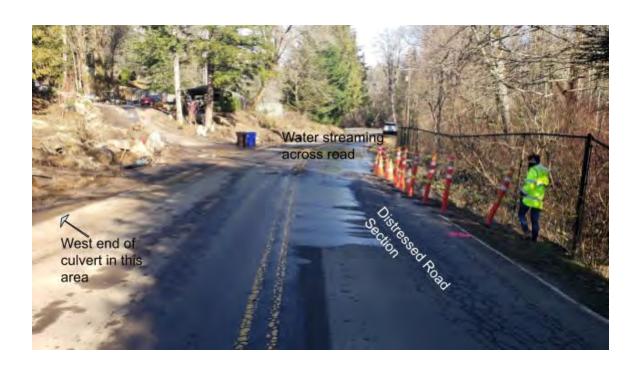
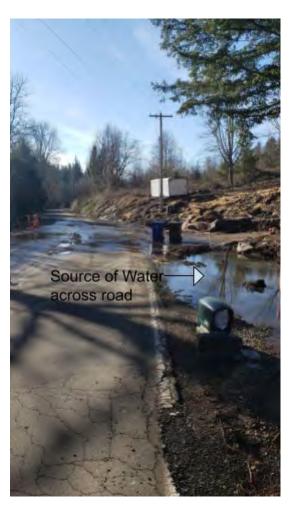
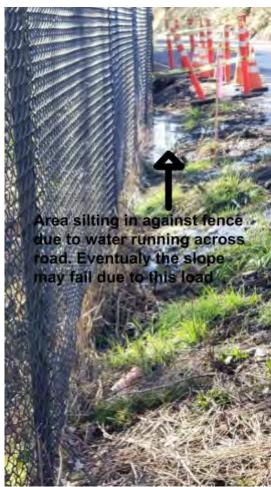
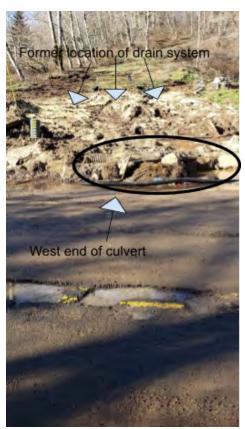
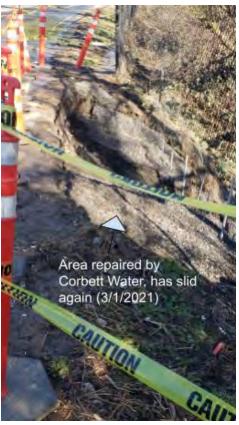
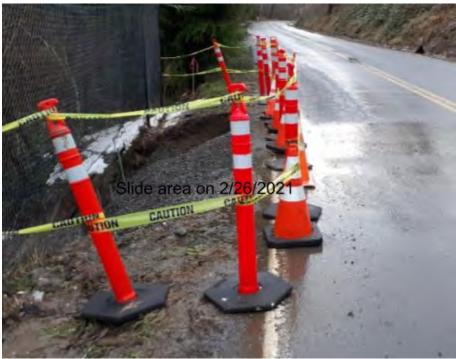
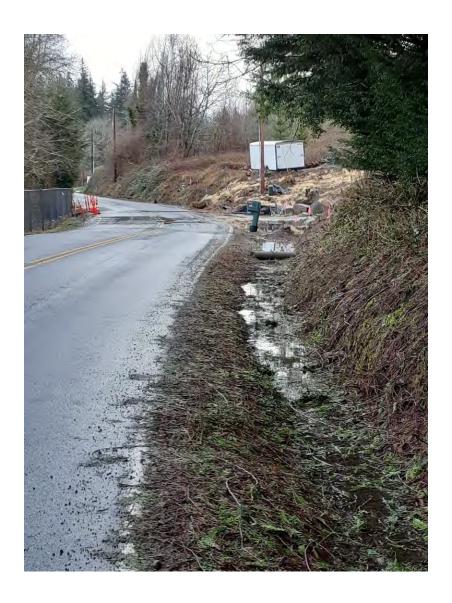
600 SE Pounder said that the previous owner of 645 SE Pounder worked with County Land Use to install drainage piping all over the slope to the south of the 645 house on the west side of the road. At least some of that drainage piping appears to have been removed (you can see the remnants of it laying all over the property). Water is sheeting off of the slope in multiple areas, flowing down to the road.

The west end of our culvert (inlet), which could help drain that water into Pounder creek, is not visible and is likely completely buried, either under mud and hay bales, or under large rocks and silt. The exact location of the culvert inlet is difficult to determine. The east end of the culvert (outlet) is visible from the roadway and appears to have a very small amount of water flowing out of it and into Pounder Creek.

Some of the water coming off the hill on the south side of 645's driveway is flowing down a newly cut ditch (presumably by the 645 homeowner) along the County ROW from 645 all the way to the shared drive way of 821/915/921 SE Pounder Rd. About 520 feet of new ditching has been cut along the County ROW.

In addition to the water coming from the slope south of 645's driveway, there is also significant ponding just north of the driveway. There is an existing ditch that runs along County ROW north of the driveway and there is likely a culvert beneath the driveway that is no longer functioning, leading to the ponding. This water has filled the existing ditch and is sheeting across the road, just north of the failure across the road.
