RE: Metro's North Tualatin Mountains  
Case #T4-2017-9166 – Comprehensive Plan Text Amendment  
Case #T3-2017-9165 – Use Application  
**Response to Request for Additional Information**

**WETLAND DELINEATION / DETERMINATION REPORT COVER FORM**

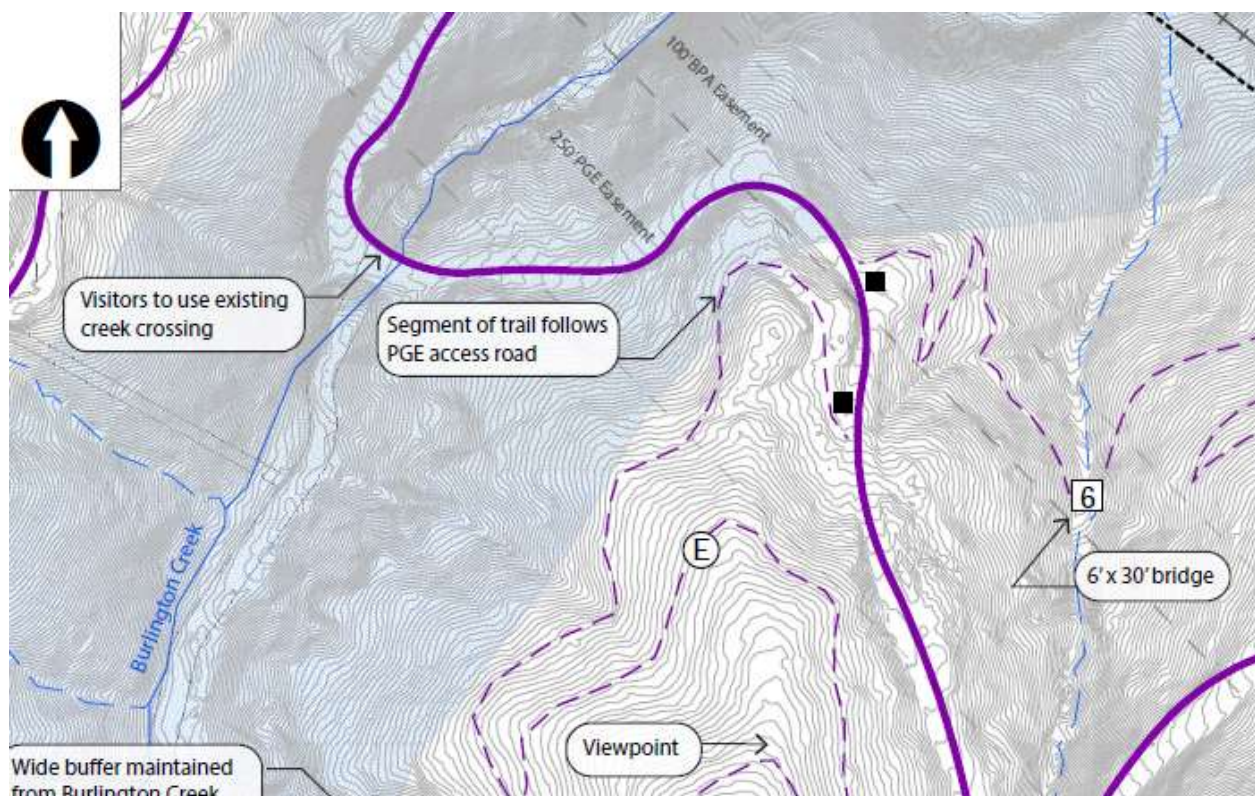
30% Trail Alignment and SEC-s Buffer

The SEC buffer in the graphic above is drawn at 328' from Burlington Creek as measured along the slope. There is no impact to the SEC-s resource requiring mitigation.
