SUPPLEMENTAL STAFF REPORT

PNG Environmental, Inc. (PNG) performed a Phase I Environmental Site Assessment (ESA) at the former Wagstaff Battery Manufacturing Facility, located at 2110 – 2156 North Williams Avenue in Portland, Oregon (Figure 1). The purpose of the Phase I ESA was to document current and historical information on-site and vicinity property usage, to evaluate the risk of adverse environmental impact to the site based upon those usages, and to identify “recognized environmental conditions” as defined by the American Society for Testing and Materials (ASTM). The project conforms to general standards established in 1997 by the ASTM (ASTM E-1527-97). The scope of work for the Phase I ESA includes:

SITE PHOTOGRAPHS
 PHASE I ESA
 PORT CITY DEVELOPMENT CENTER

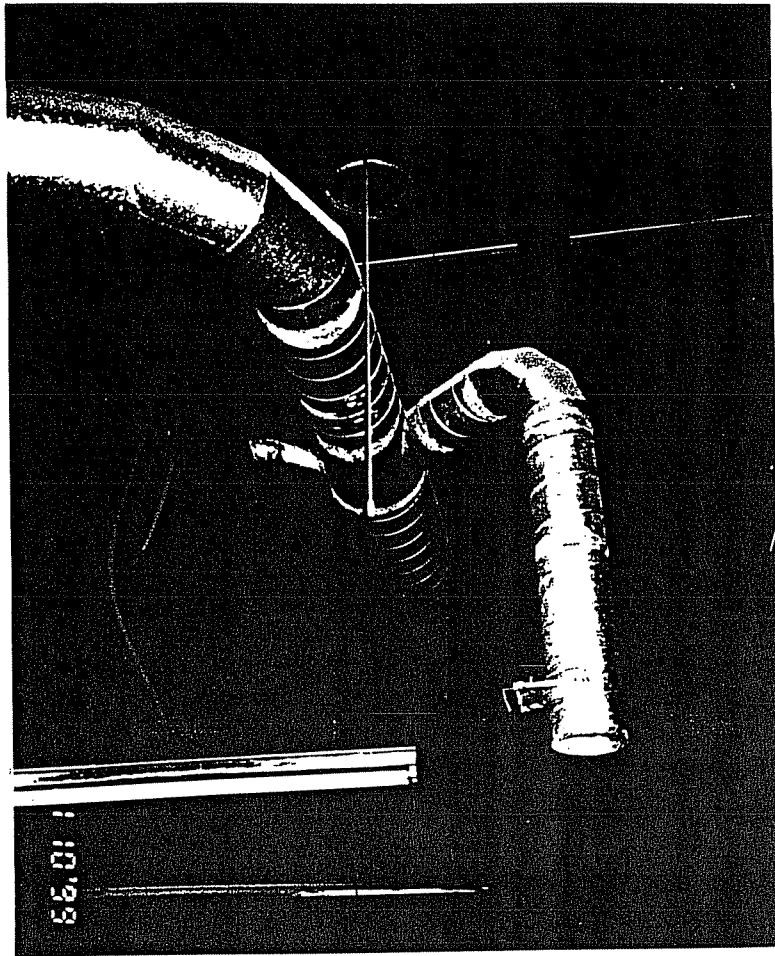
Photo 3: New and older overhead exhaust ducts in Building 1B are covered by dust residue.

- Sample and test building materials for chemical and/or asbestos hazards (floor, wall surfaces, and overhead ducting in Building 1B, potential asbestos floor tiles in Buildings 1B and 2) to evaluate worker safety and disposal issues.

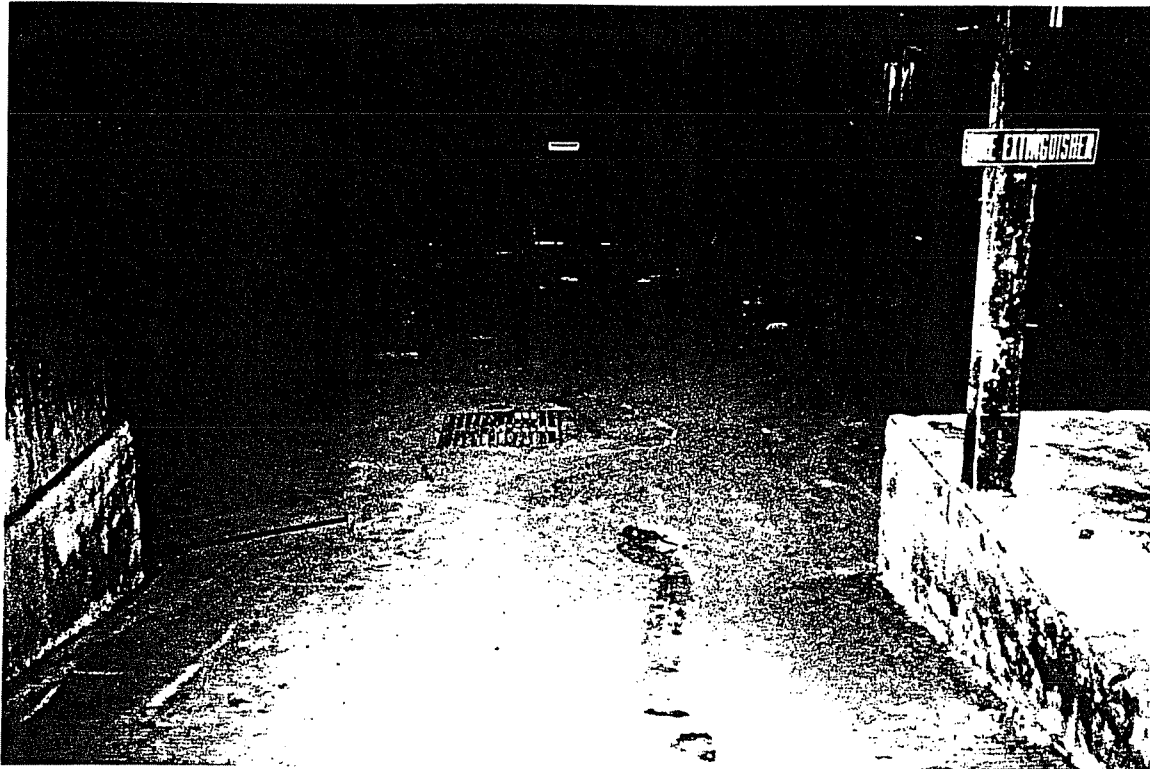
Photo 5: View to the west, former pasting room of Building 1B.
Sump 2 at center. Small valve box at far right (see Photo 6).

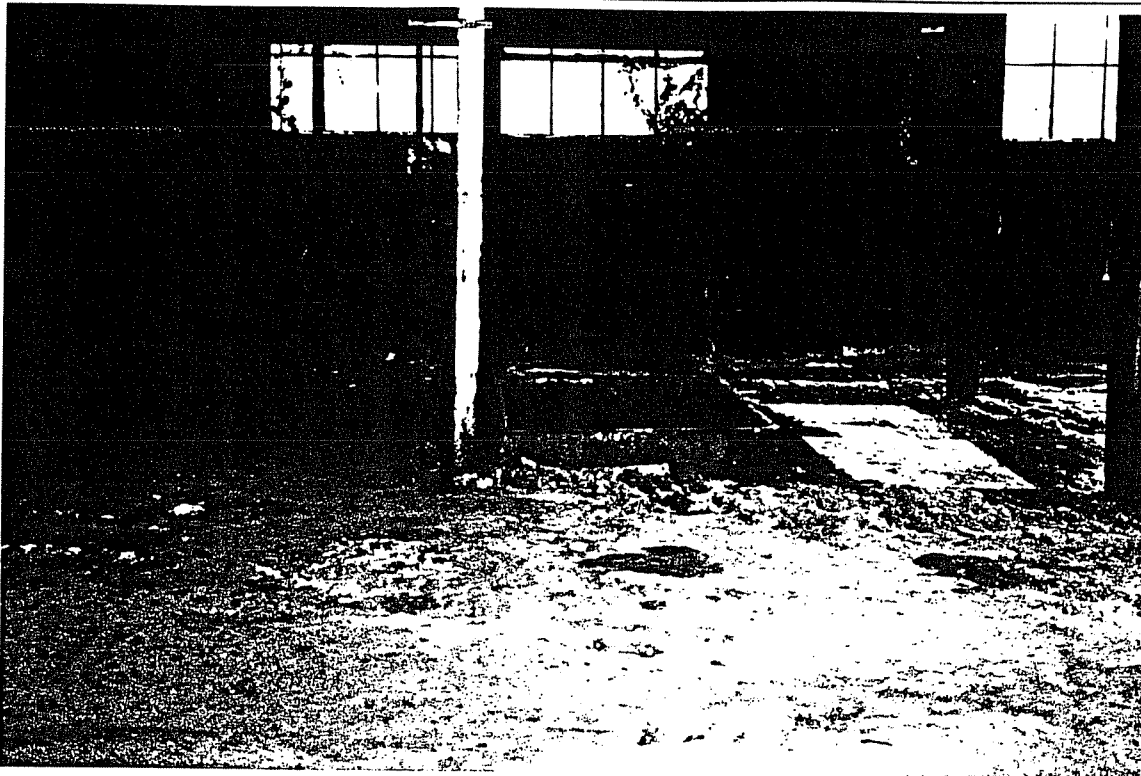
A processing room is located east of this loading bay area, in the northern portion of the building. The concrete floor in this area of the building is severely pitted and degraded. Two catch basins ("Sump 1" and "Sump 1A") are located in the north-central portion of this area, both in corroded and poor condition (Photo 7). Pavement surrounding the two catch basins appeared to have been patched asphalt in poor condition, and was covered with a yellow crust. The western catch basin is covered by a rectangular steel lid measuring approximately two by three feet, and the basin itself is circular. This resembles "Sump 1" as photographed in the 1997 InterMountain West Report (Photo 8; also see Section 3.8.4). A second, larger catch basin is located approximately ten feet east of the first. This second basin measured approximately four by six feet, with a steel grate below grade (Photos 7 and 9). PNG did not determine whether the basin floor surfaces were sealed. Sump 1A was photographed during a 1992 DEQ site inspection, and appears to have been used to contain acids and process wastewater during the battery manufacturing and repair operations (Section 3.8.1 and Appendix H). Sheets of degraded plywood covered the floor along the northeastern wall of the building. Two large exhaust fans are located along the eastern wall of this area. Several patched holes in the floor, resembling previous drilling locations, are located west of the southern exhaust fan.

Photo 7: View looking north inside Building 1B, showing Sump 1 (left) and Sump 1A (right). Note poor condition of floor.

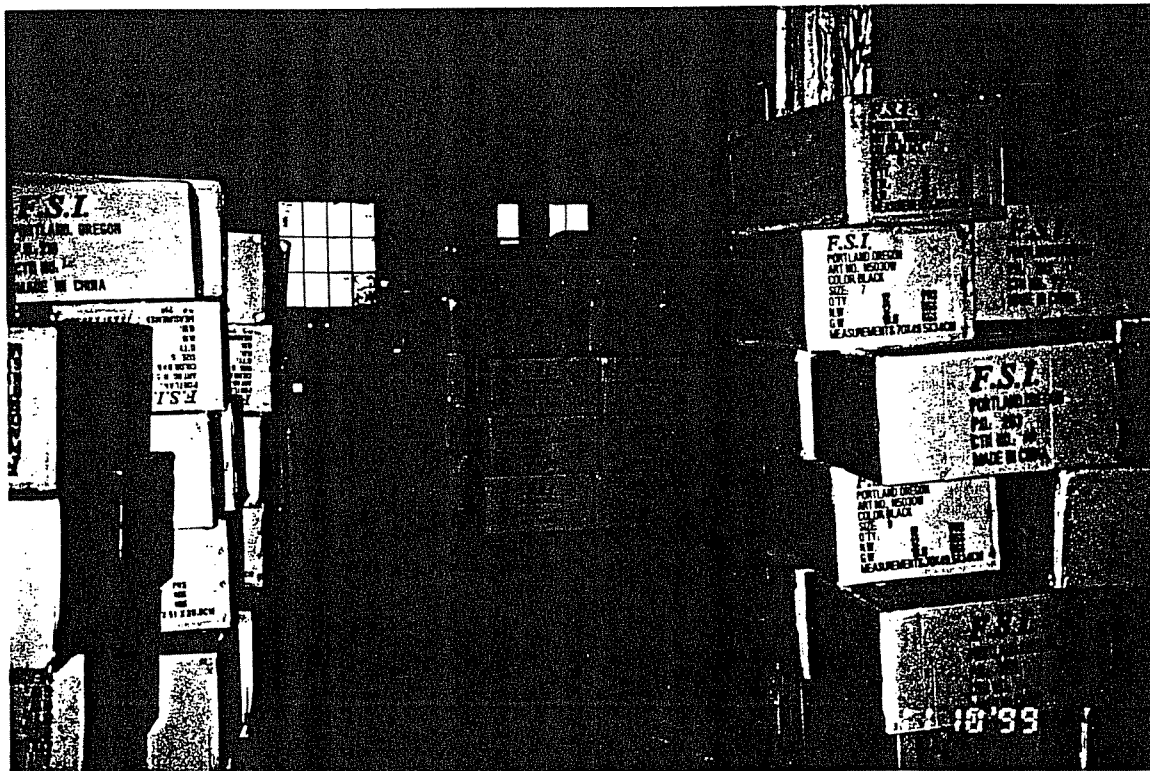
Photo 10: Interior of Building 2, looking west.

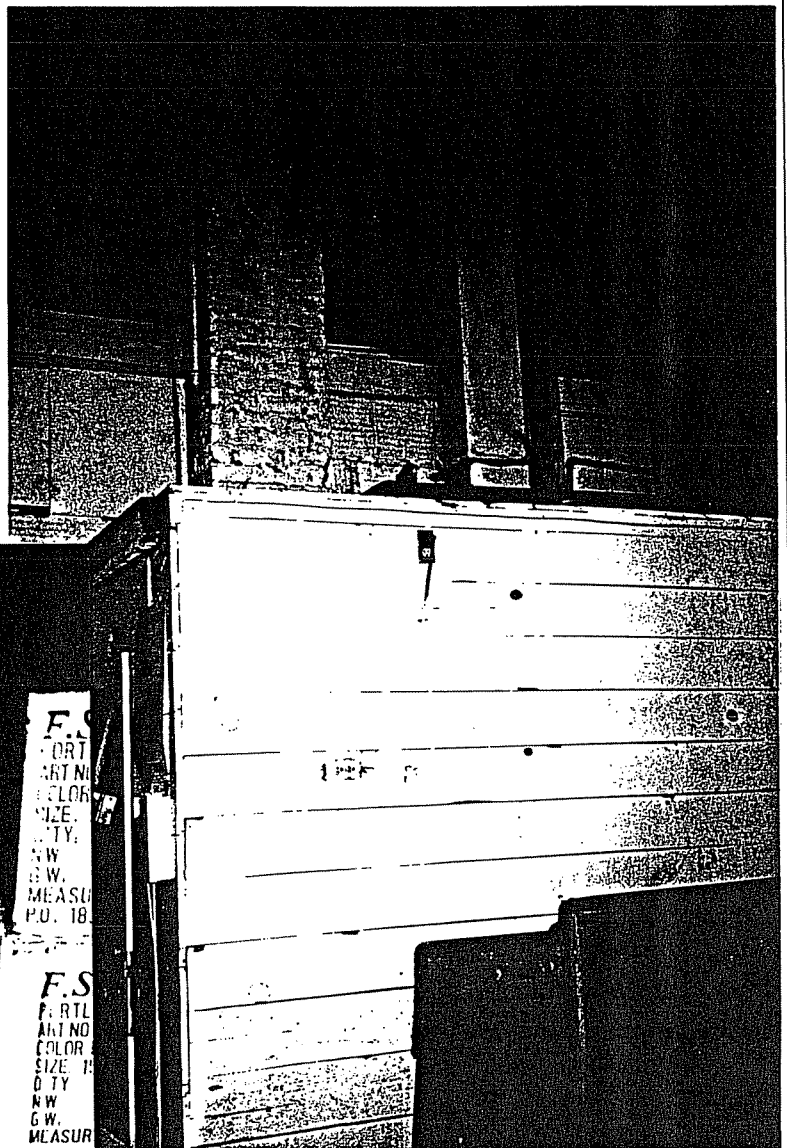
Photo 11: Interior chimneys, Building 2.

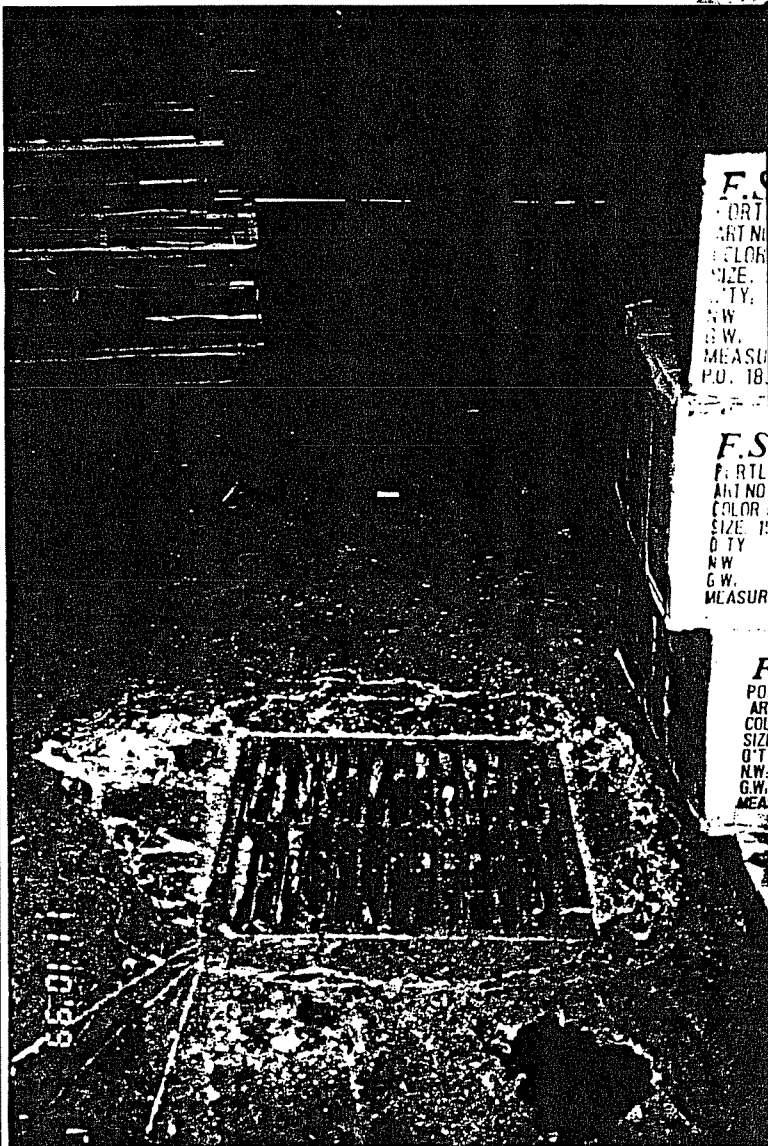
observations were limited because the building's lighting system was inoperative, and numerous stacked boxes covered most of the shop's floor area. PNG observed one indoor catch basin in the northeast corner of the former shop area (Photo 12). This basin was referenced in previous reports as "Sump 3" (see Section 3.8). The floor surface surrounding the catch basin was cracked and discolored. A fenced and paved yard area separates Building 2 from Building 1B to the south.

Photo 12: Sump 3, inside Building 2.
