COOPET QUARRY - EXISTING TOPOGRAPHY

ODOT - PRE-APP 6.15.17

RE: Biological Resources Impact Memo
Coopey Quarry Disposal Site Maint Number: 17016
Multnomah County, Oregon

**Coopey Quarry.
ODOT M17016
Wetland and Waters Delineation Report
Multnomah County, Oregon**

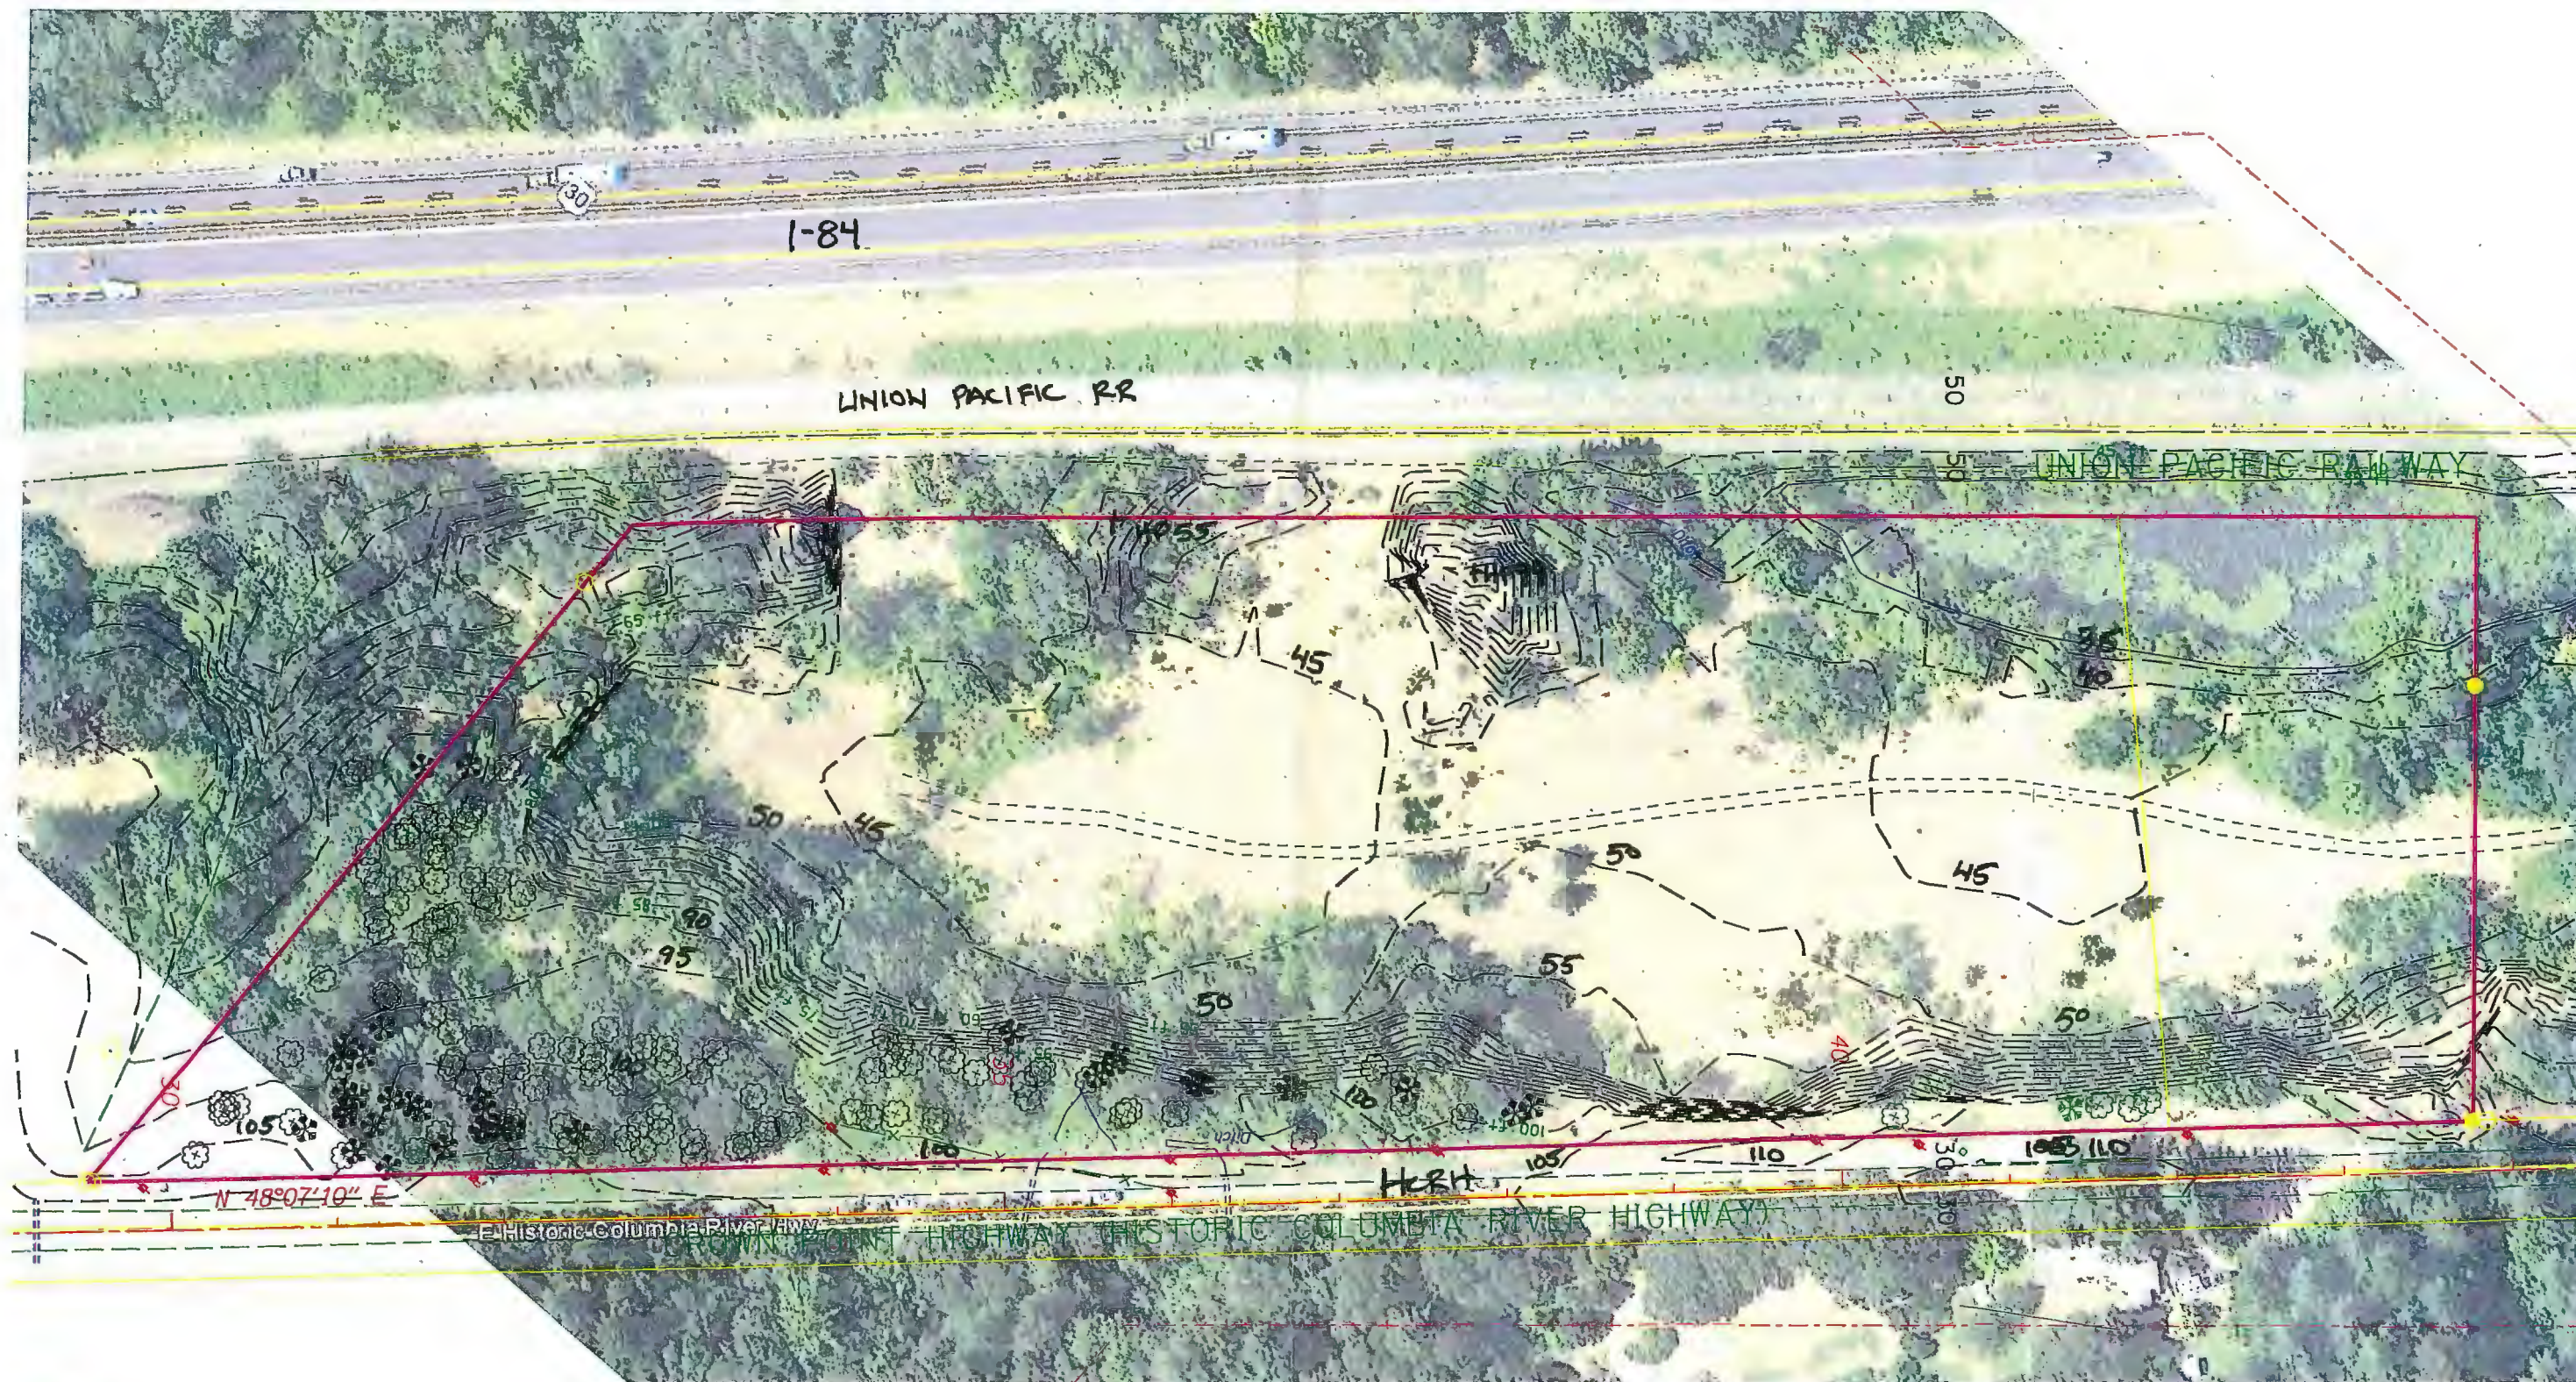
NOTE: CONTOUR INTERVALS 5'

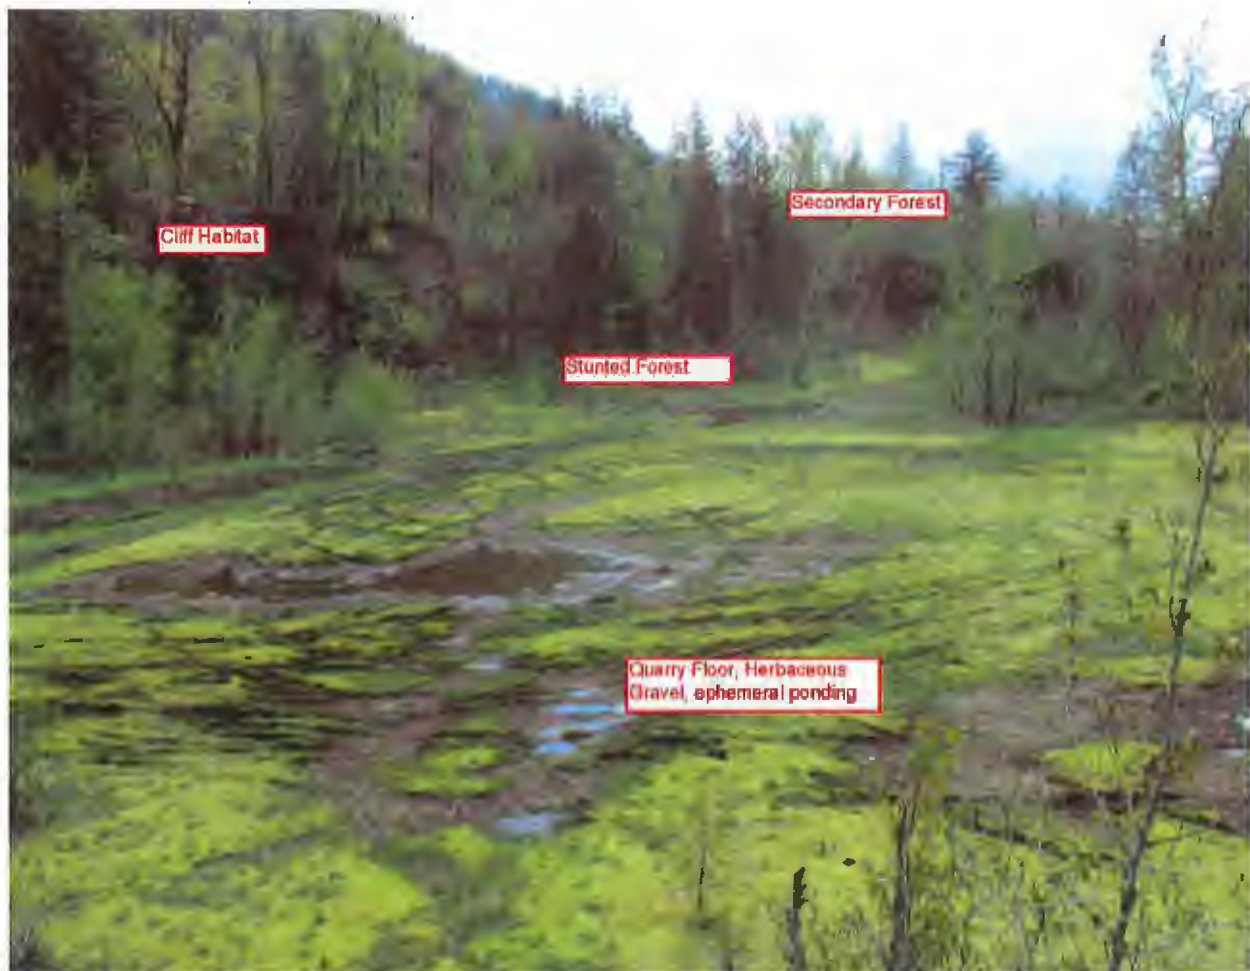
Figure 5. Representative photos of habitat within the quarry site including damage from recent mudding scars. Foreground has quarry bottom of mainly gravels over bedrock, background shows the limited cliff habitat and scrub forest. Secondary forest is restricted to above cliff face. Ephemeral runoff ponding from shallow bedrock shown.

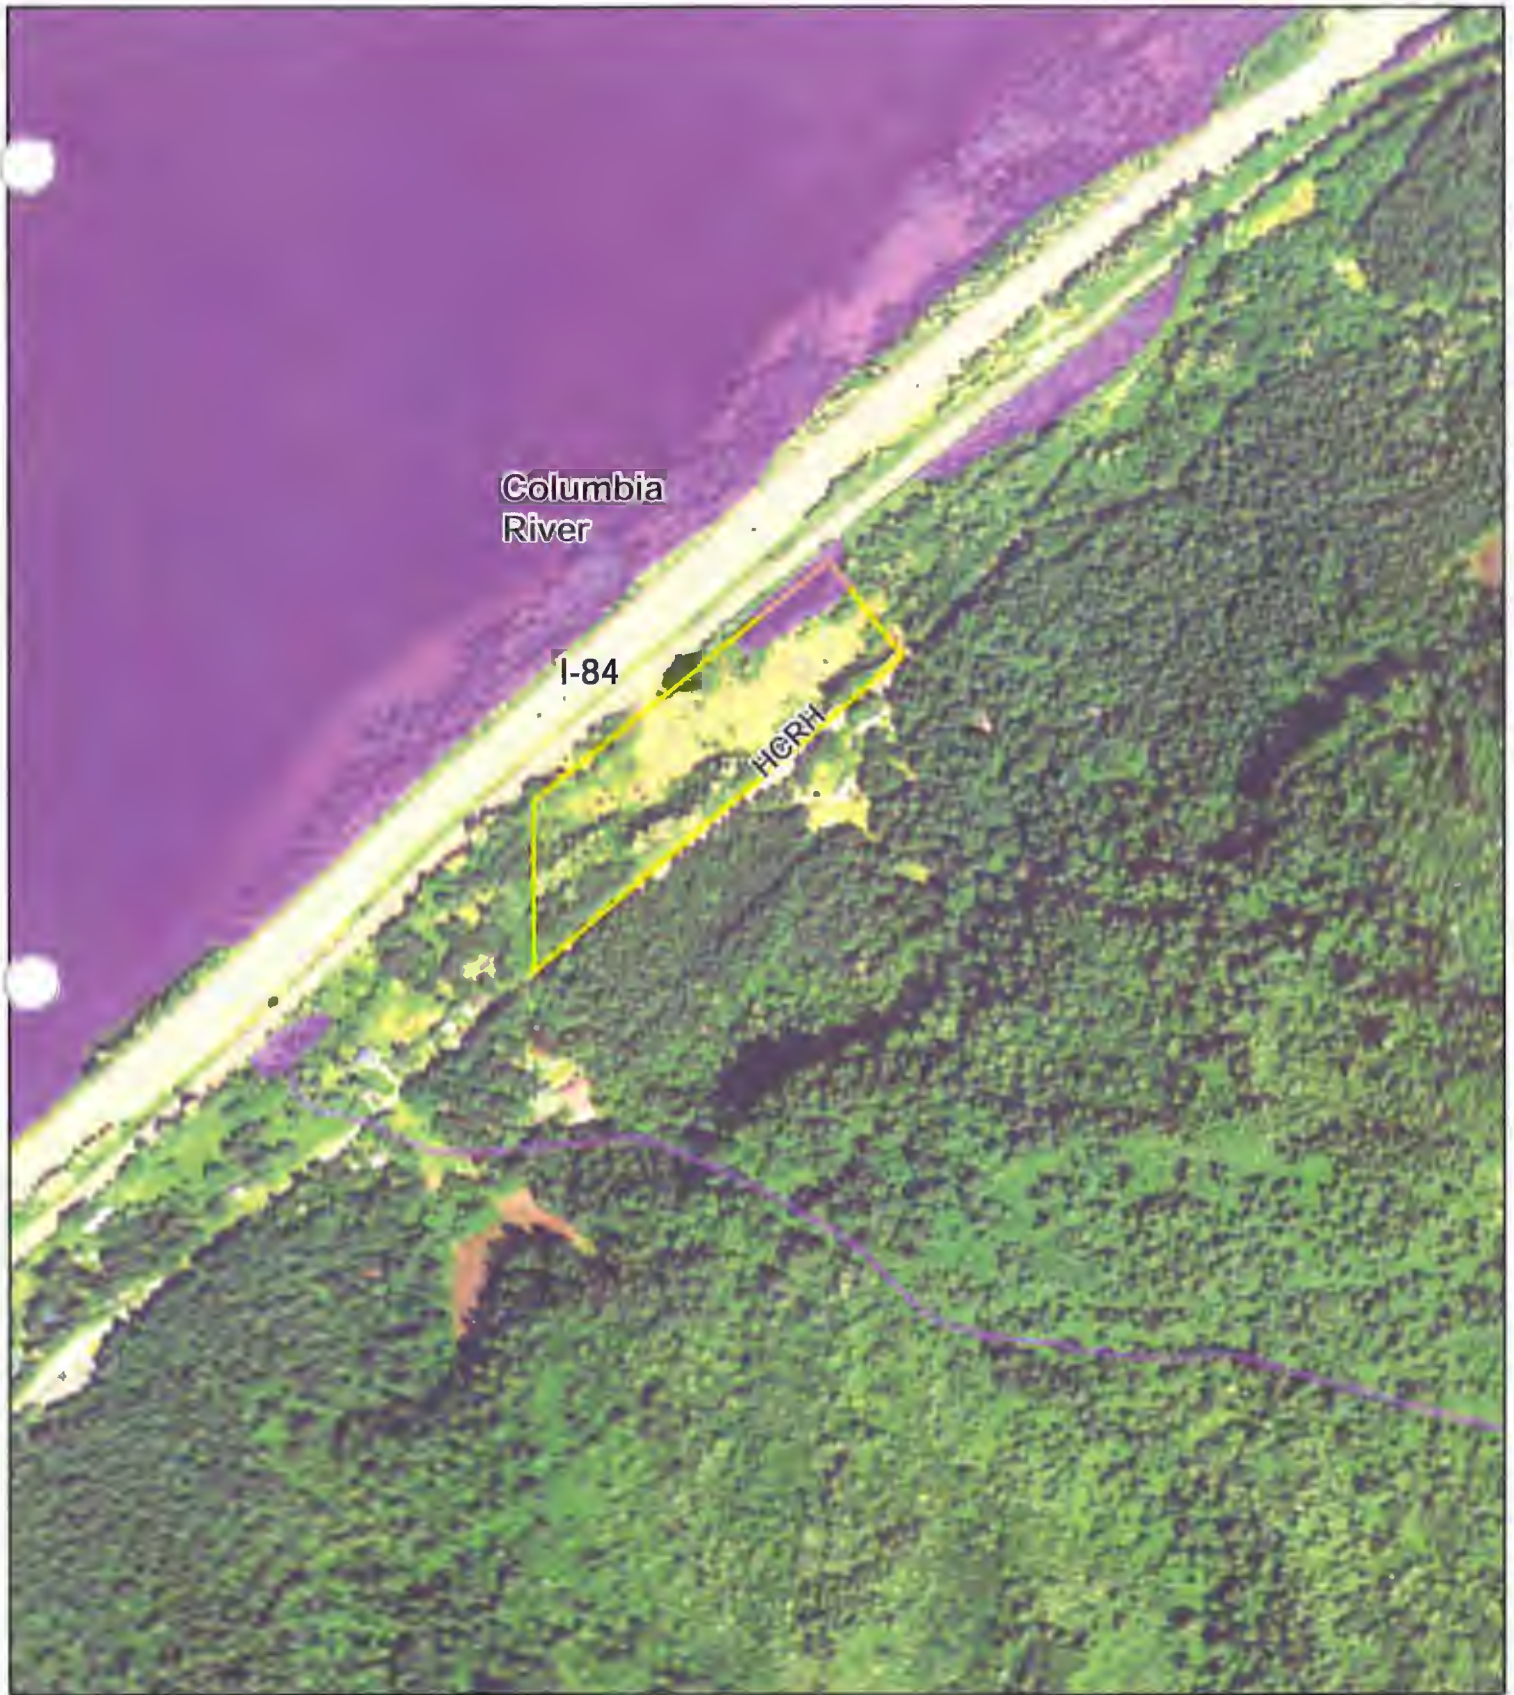
OREGON DEPARTMENT OF TRANSPORTATION
Coopey Quarry
Figure 3
Wetland Inventory

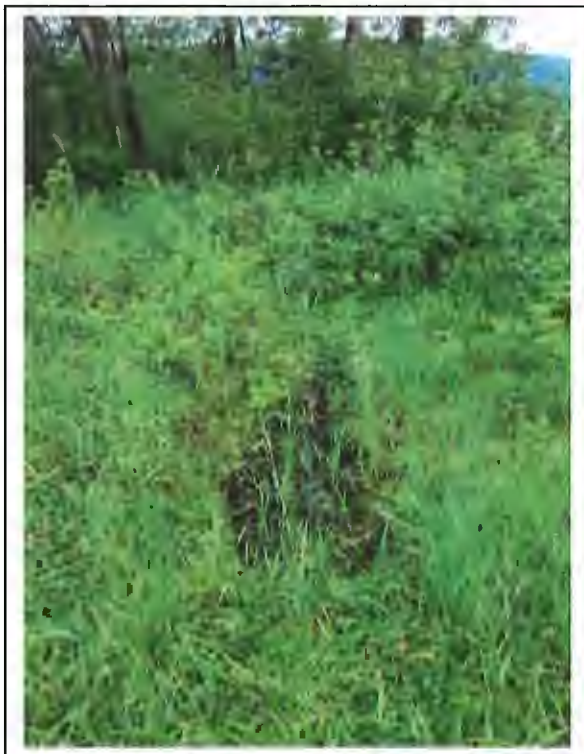
Photo 1. Wetland A looking north
from HCRH. June 1, 2017

Wetland A: Wetland A is a narrow ditched wetland. It receives water from stormwater runoff from the HCRH and a small depressional wetland south of the HCRH. Water flows north through the wetland and over the quarry wall. The wetland is seasonally wet, drying out on most years by the end of June. The wetland is dominated by reed canarygrass with water parsley in the wetter portions and Douglas spirea along the edge. Large black cottonwood trees are found outside of the wetland to the north. A high water table in April demonstrated the presence of wetland hydrology. The soils are a mottled silt loam indicating seasonal saturation. The Wetland was delineated by a sharp topographic break, soil saturation, presence of mottles and a change from vegetation dominated by reed canary grass to one dominated by Armenian blackberry and Wood's rose.

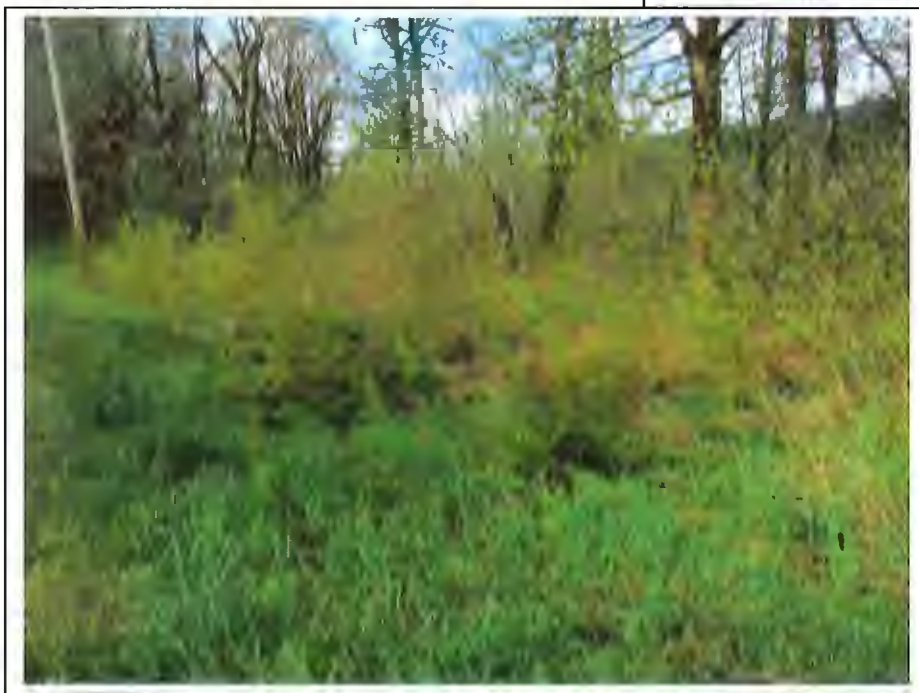
Photo 3. Wetland C taken
from near the HCRH
looking northwest. April
18, 2017

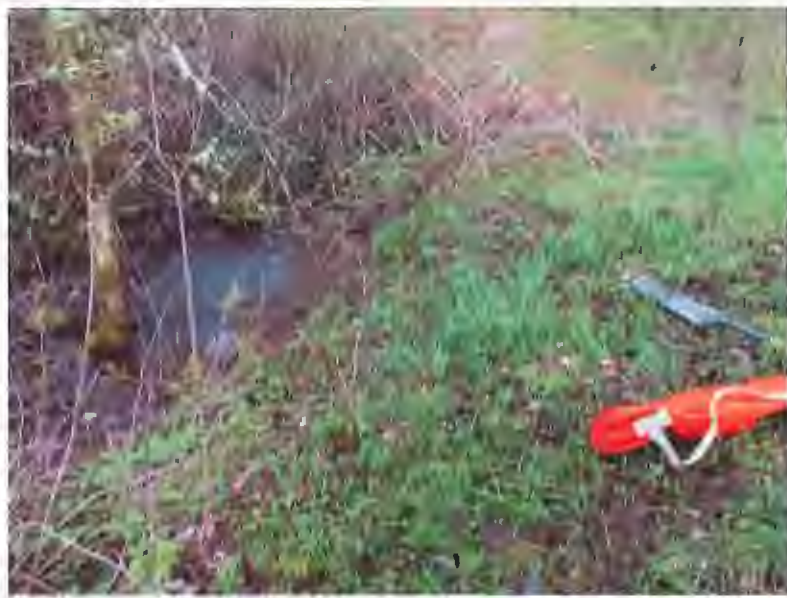
Photo 4. Wetland D
looking north west from
edge of wetland.
5/31/2017

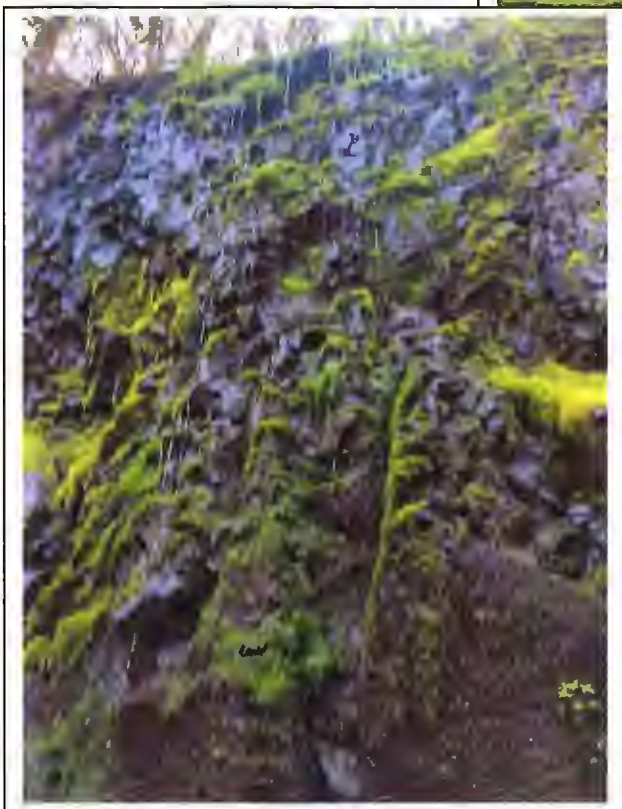
Photo 9. Rock face below wetland ditch.

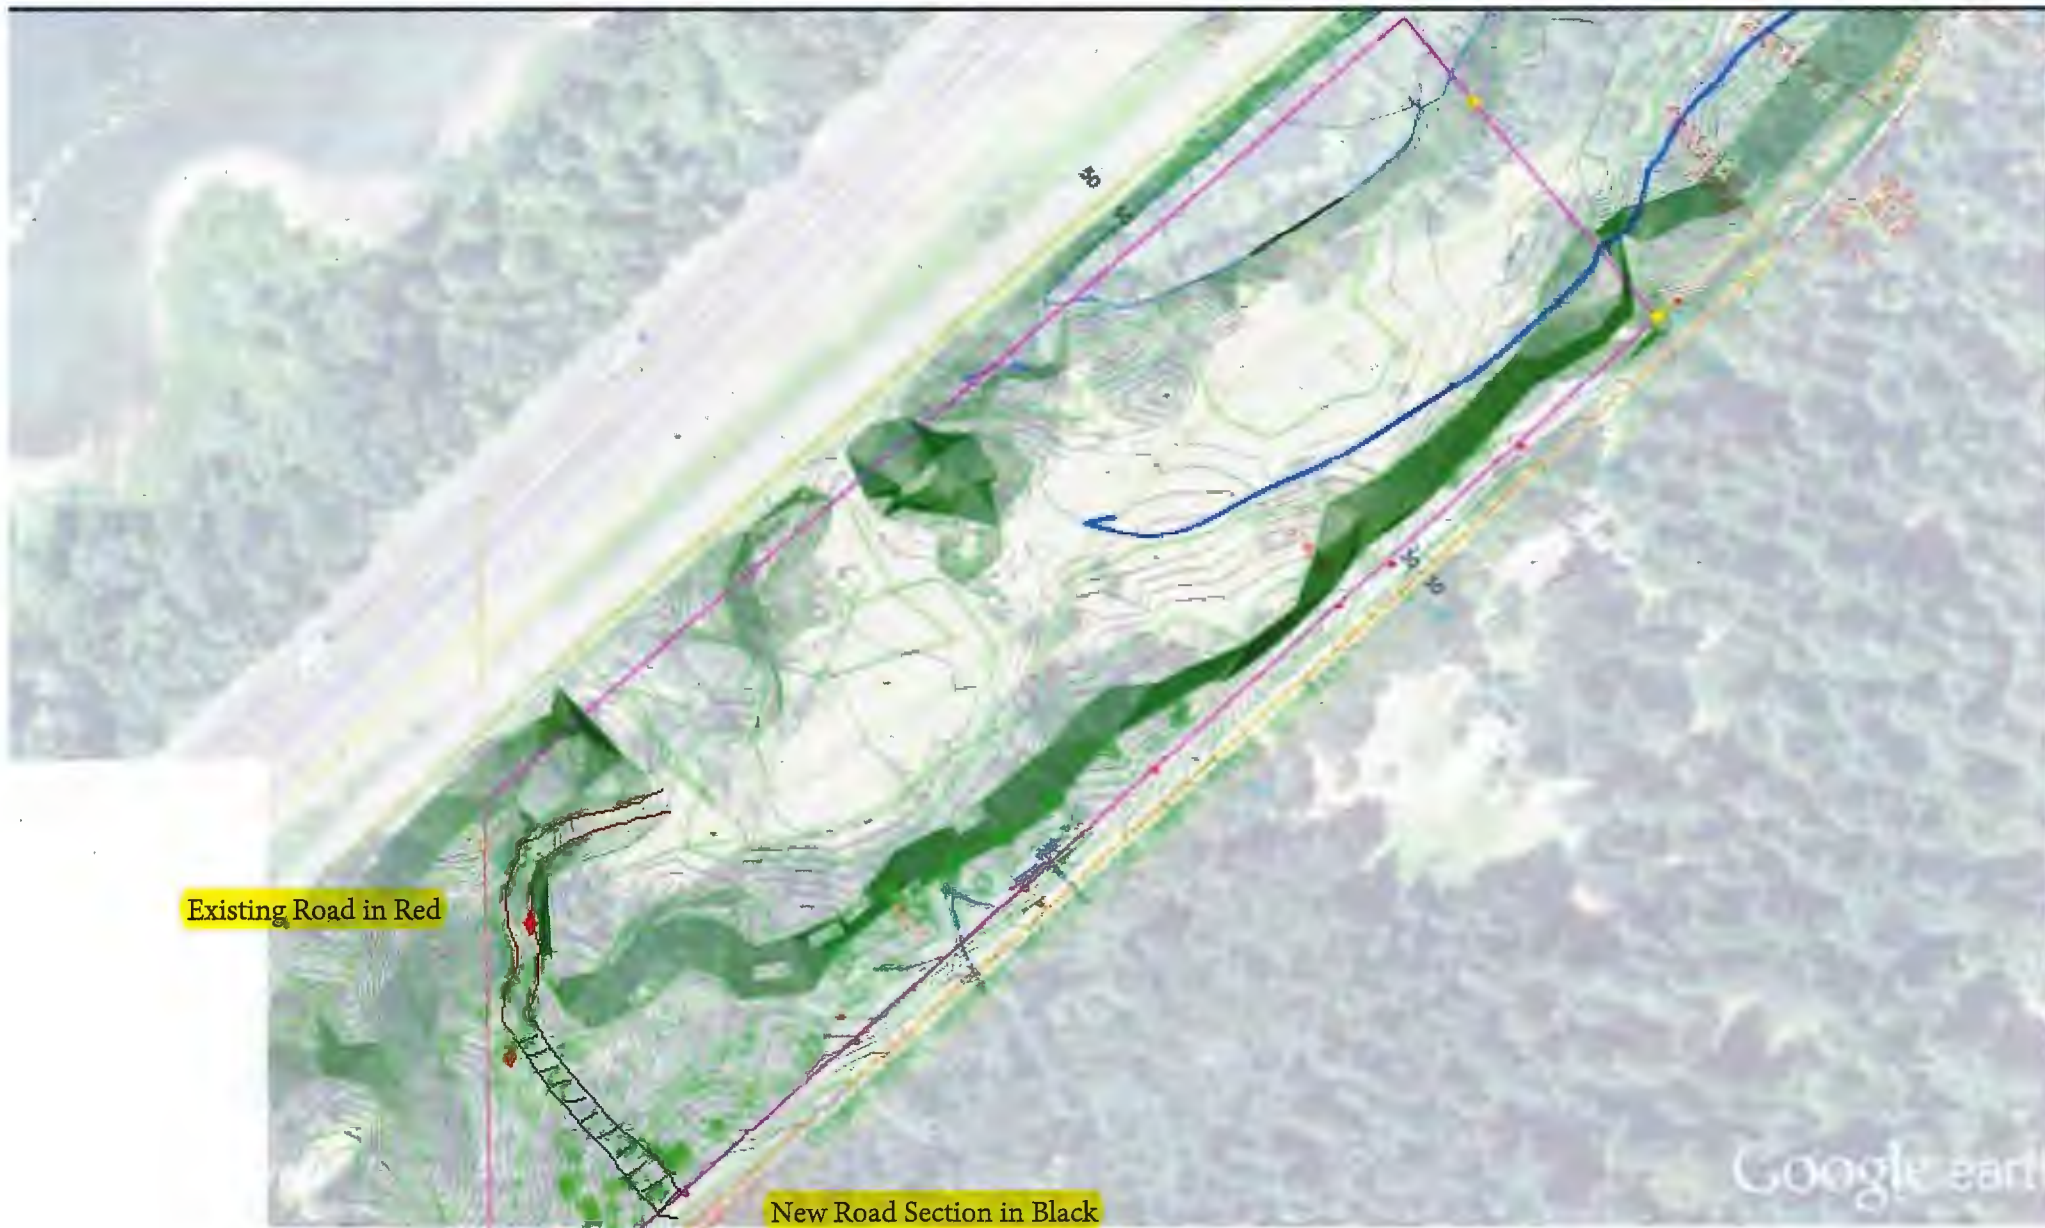
Coopey Quarry APE with Contours and Proposed Access Road

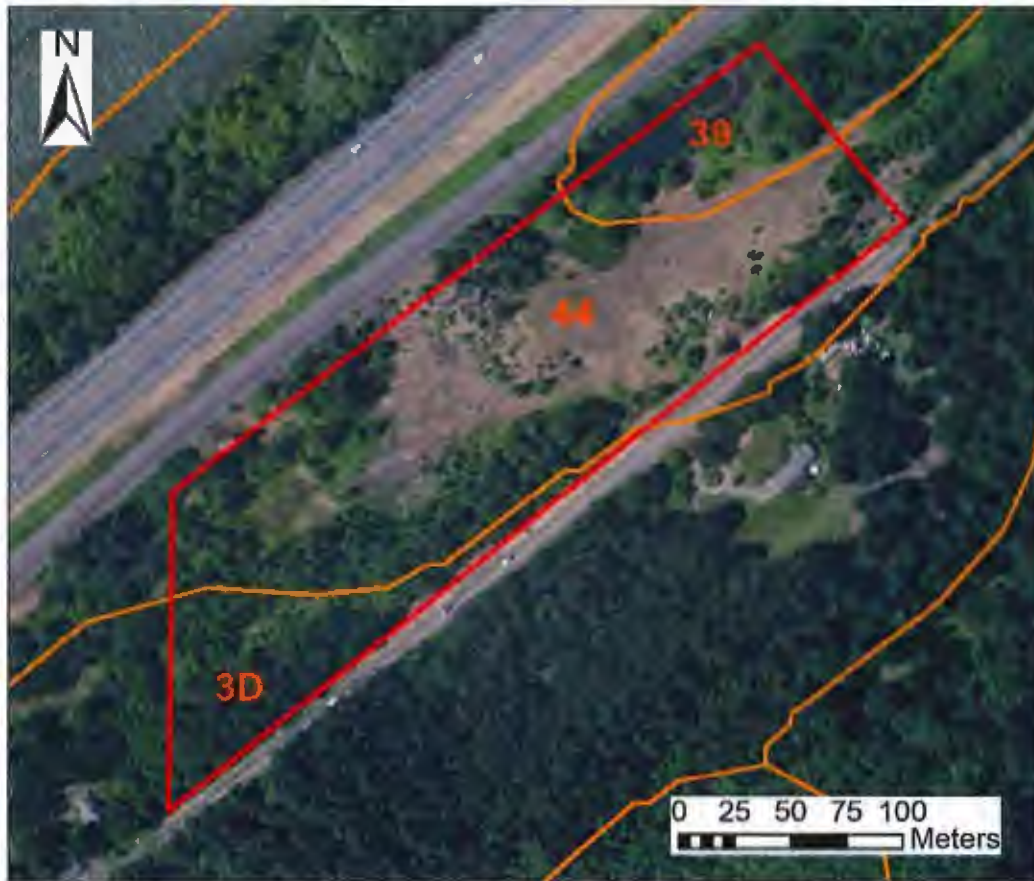
Figure 3. Map showing the mapped soil units within the current project area.

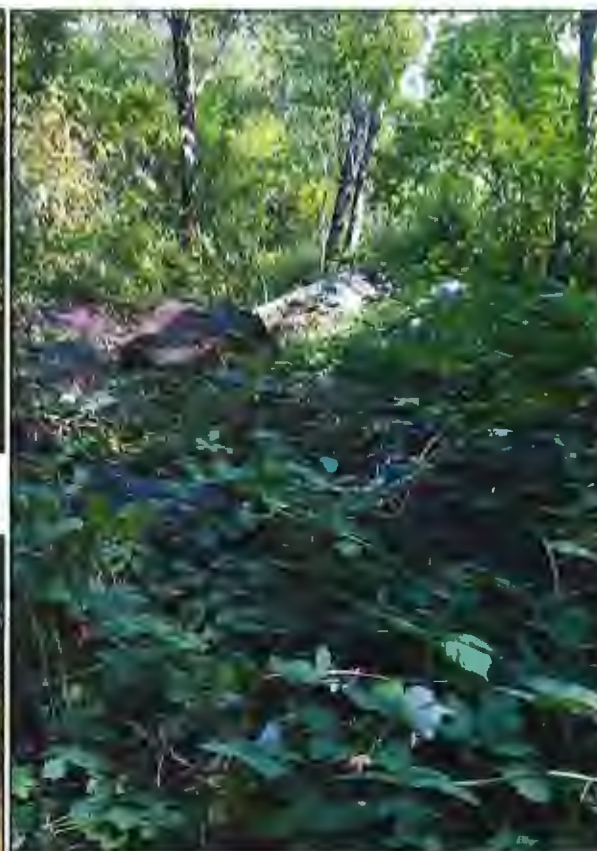
Figure 11. A large pile of modern debris has been dumped over the quarry edge and rests in the southwest portion of the quarry.

Disturbances to the project area are cover more than 90% of the APE due to the previous quarrying activities conducted here. These include the removal of a large quantity of gravels and rock, and construction of east and west access roads. Dumping of domestic debris, appearing to be late 1960s to the 1970s in age, has occurred in the southwest portion of the quarry. Materials noted include a trailer, tires, refrigerators, galvanized pipe, garden equipment, carpeting, and domestic refuse (Figure 11).

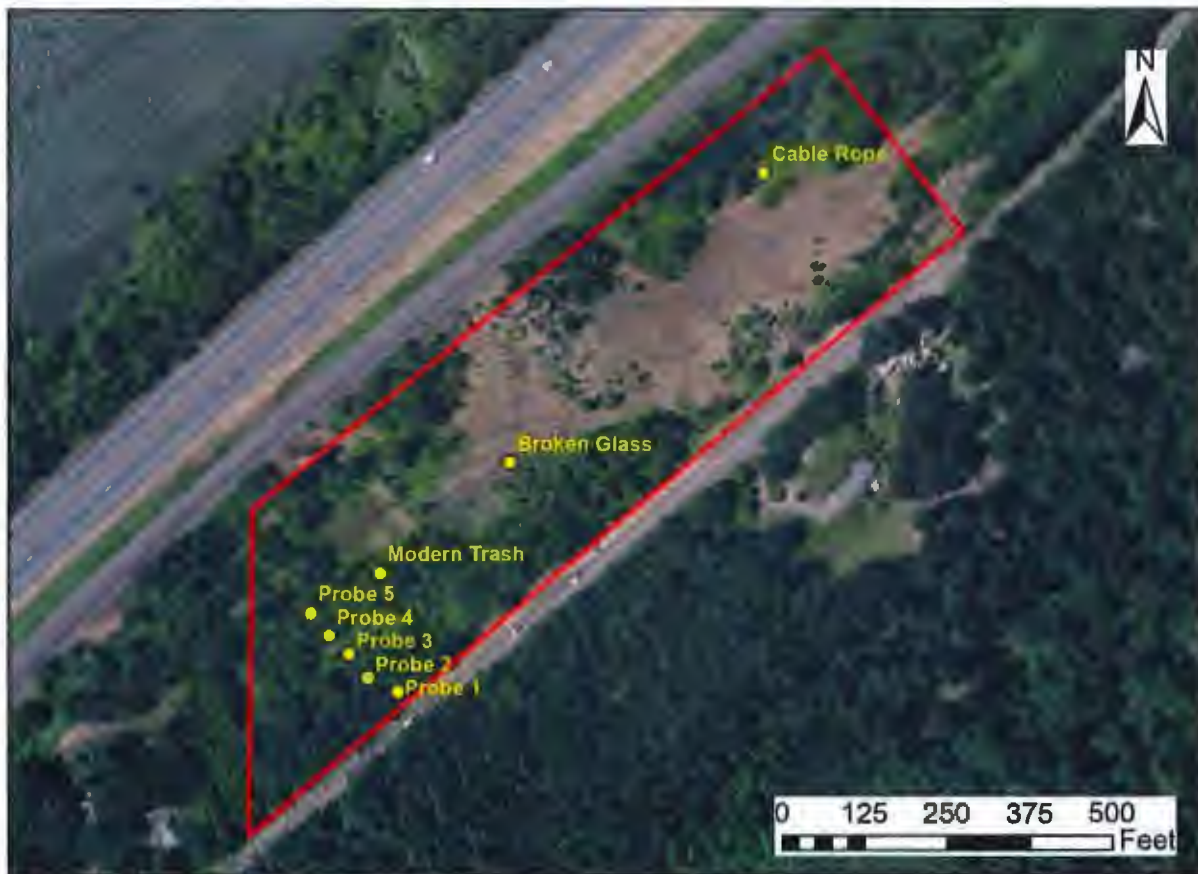
Figure 14. Location of probes and cultural material noted within the current project area.

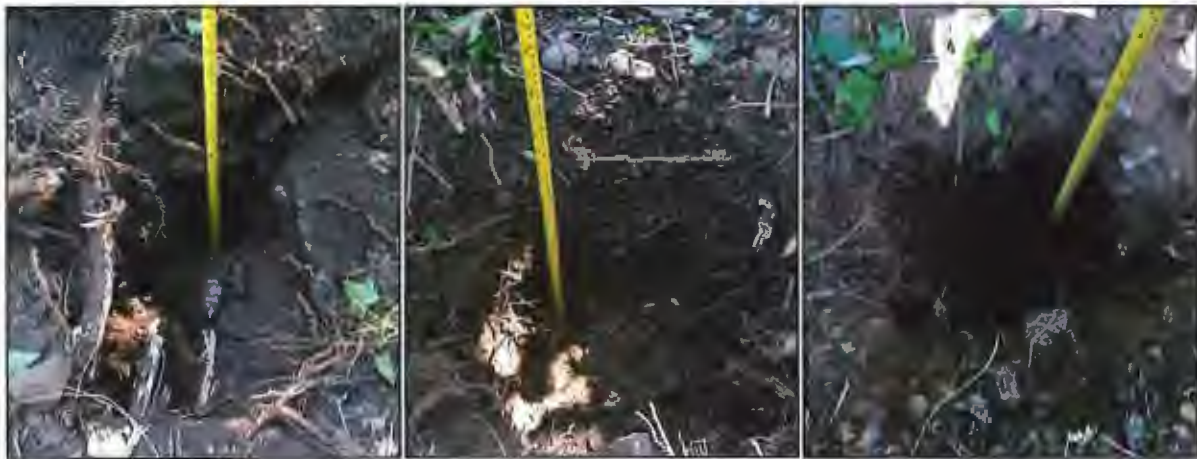
Figure 15. Probes 1, 2, and 3, showing the cobbly loam sediment matrix.

Sediment encountered during the subsurface investigation is consistent with those mapped by the NRCS (mapped as 3D); cobbly and very cobbly loam capped by an organic layer of decomposing plant material. Rock was subrounded to subangular and ranged from pebble to cobble in size in a medium brown loam matrix (Figure 15). Excavations began in the south, adjacent to the highway right-of-way and continued to the north, toward an existing quarry access road. Sediment became increasingly rocky and

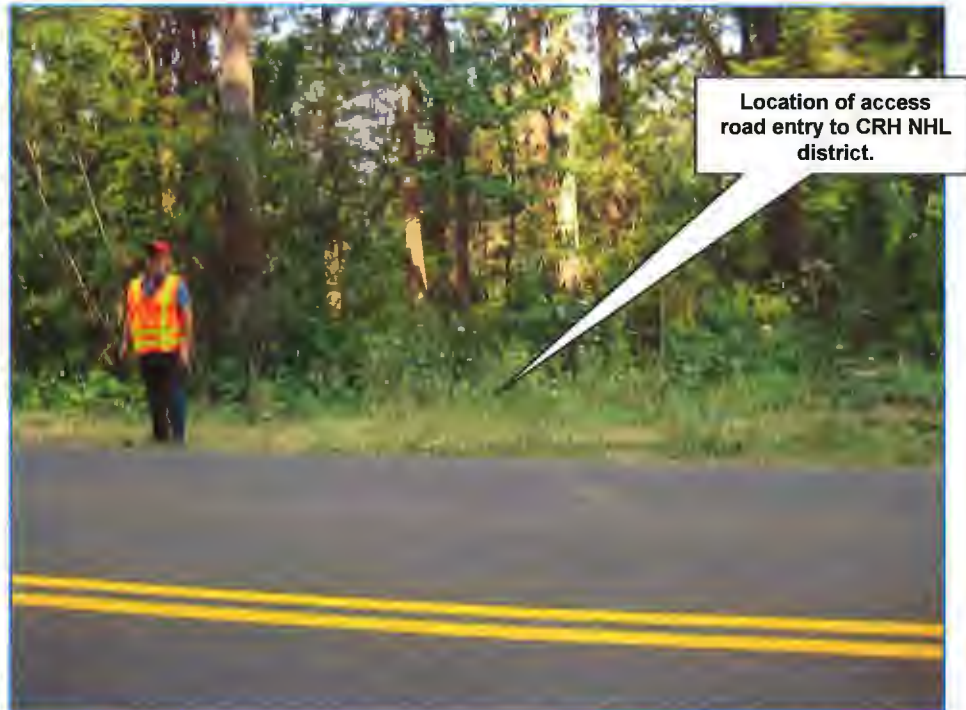
Photo 1. Looking north at the proposed Coopey Quarry access road, where it will connect with north side of CRH NHL District.
