14 DAY OPPORTUNITY TO COMMENT

Application for National Scenic Area Post Emergency Response Site Review

Case File: T2-2018-9983

Proposal: The applicant has submitted a National Scenic Area Post-Emergency Response application to authorize the emergency storage and shredding of tree materials removed as well as the installation of fencing for rockfall hazards in various locations in response to the Eagle Creek Fire.

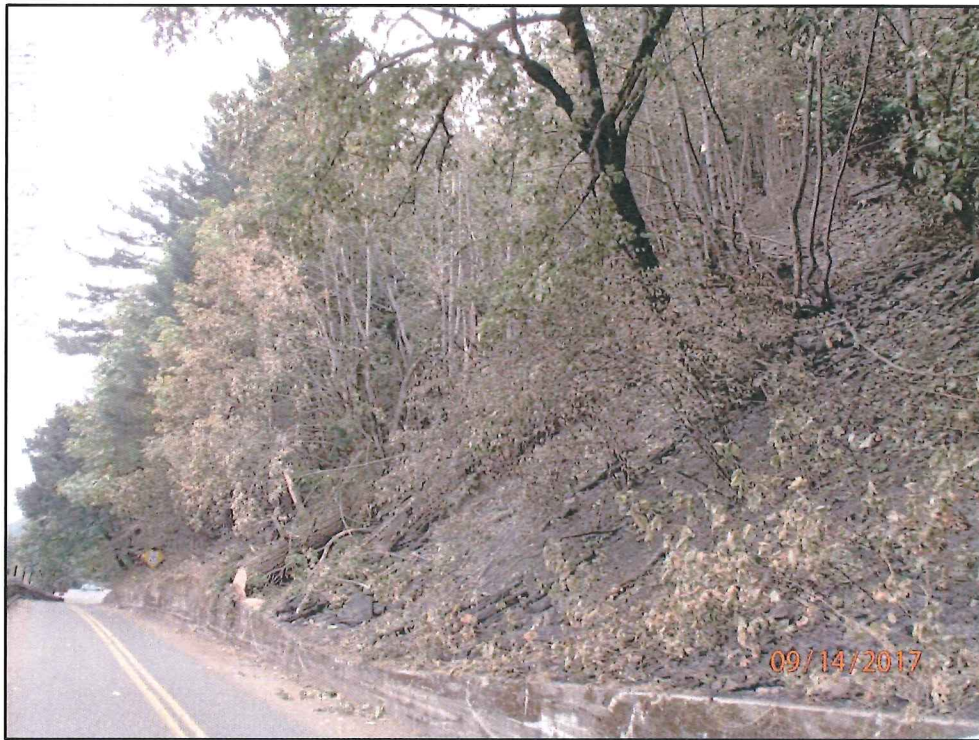
Photo 1. West Viaduct - looking east along viaduct structure towards Multnomah Falls.

The Eagle Creek Fire destroyed virtually all of the ground cover vegetation and a number of the trees. Photo 1 shows the talus slope above the west viaduct prior to hazard tree removal. Rocks up to two feet in diameter are continuously entering the roadway. Some of the rockfall is originating within the talus and some is originating from the rock outcrops above the talus slope.

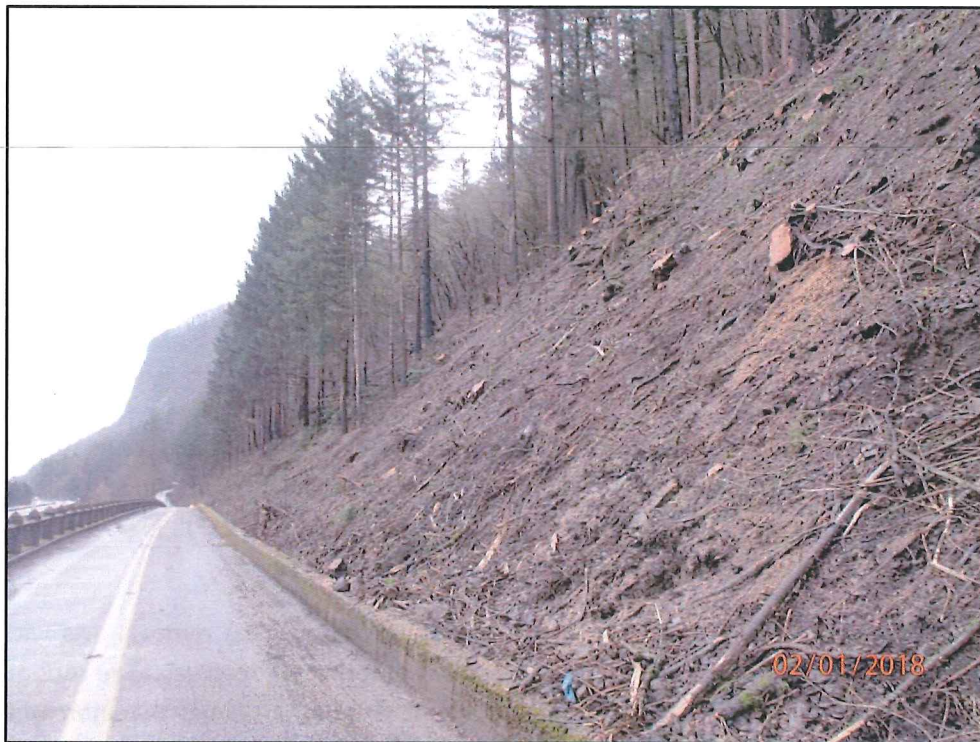
Photo 2. East Viaduct - looking east along viaduct structure.

Photo 2 shows the talus slope above the east viaduct after hazard tree removal. As with the west viaduct, rocks up to two feet in diameter are continuously entering the roadway. The rock outcrops are located farther upslope from the roadway than at the west viaduct. It appears that more of the rockfall is originating within the talus and less is originating from the rock outcrops above the talus slope, but extremely hazardous site conditions prevent a ground reconnaissance of the upslope area.

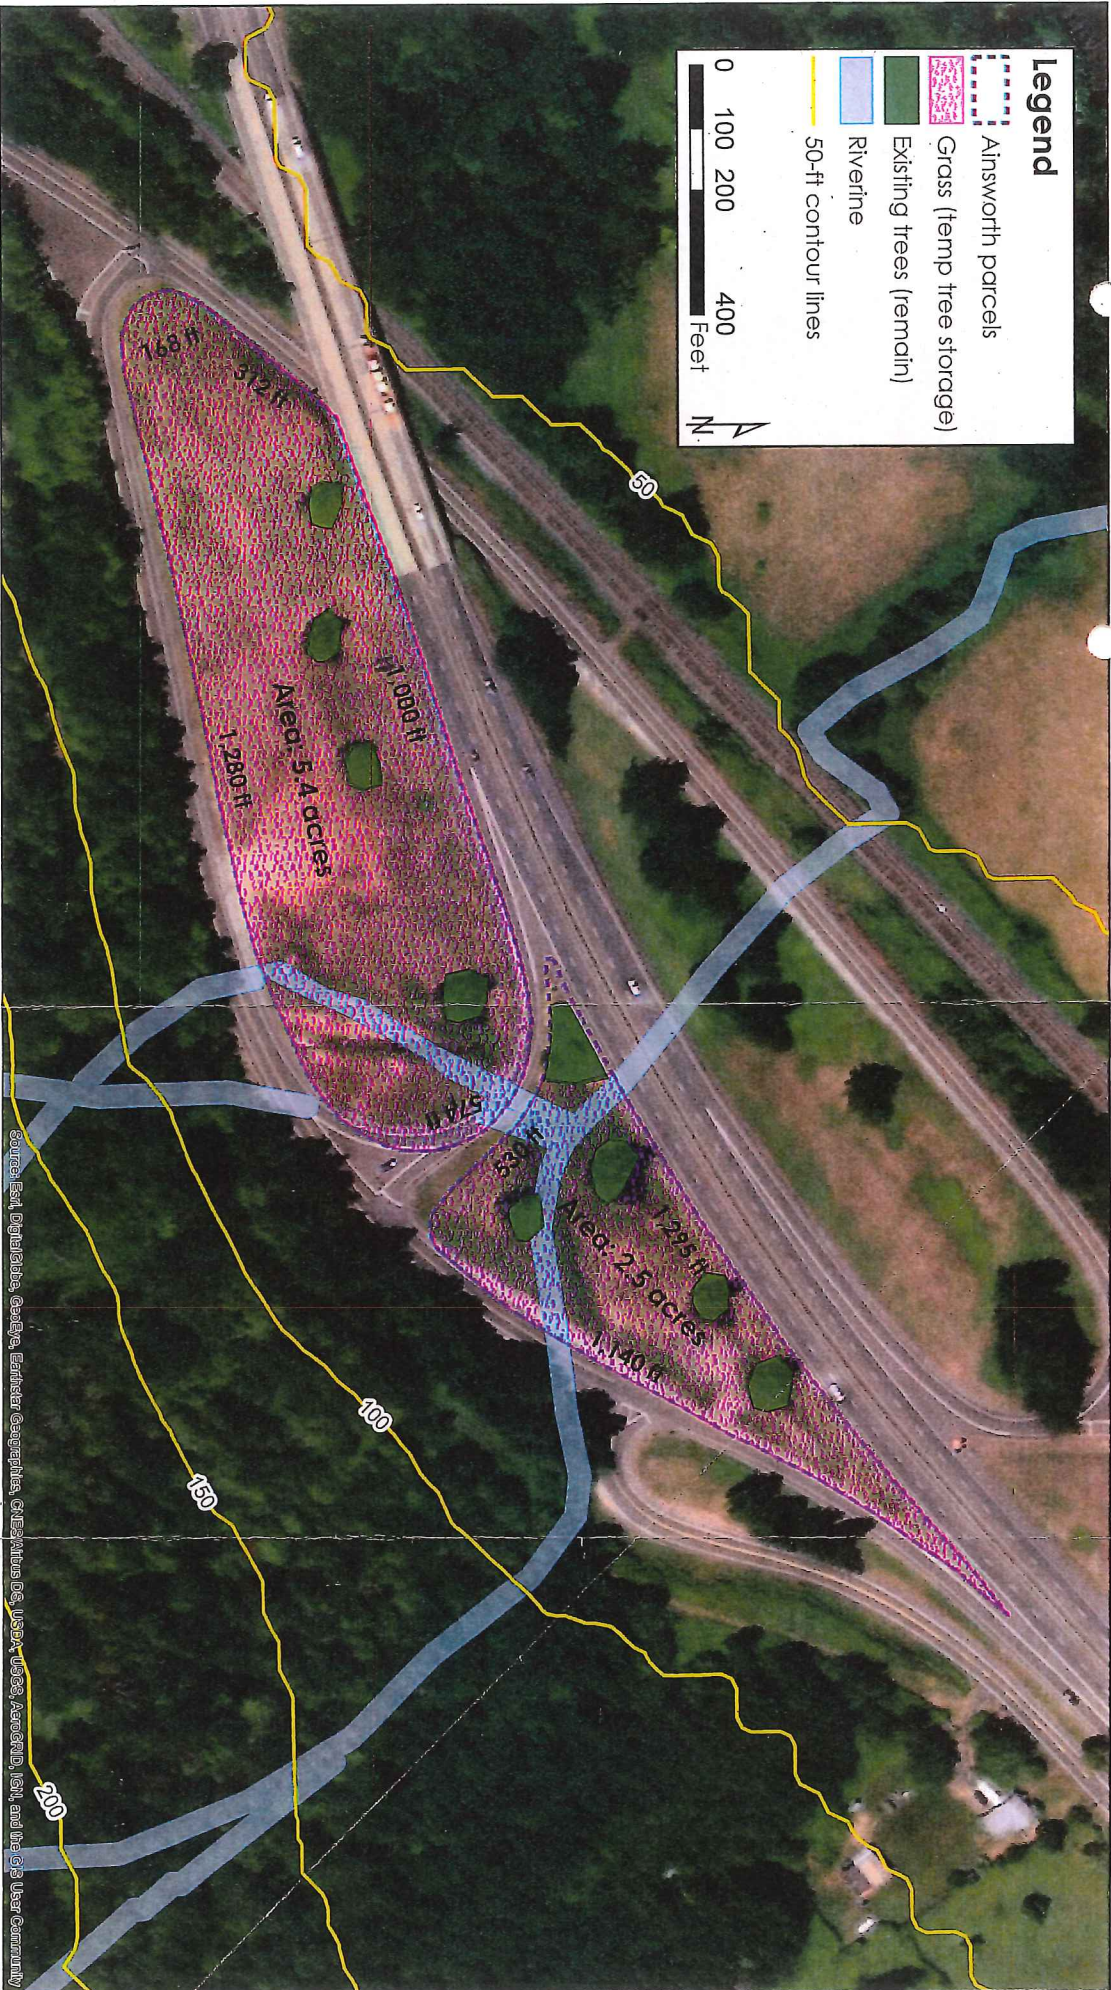
Ainsworth Emergency Permit Proposal Map

- Ainsworth parcels
- Grass (temp tree storage)
- Existing trees (remain)
- Riverine
- 50-ft contour lines

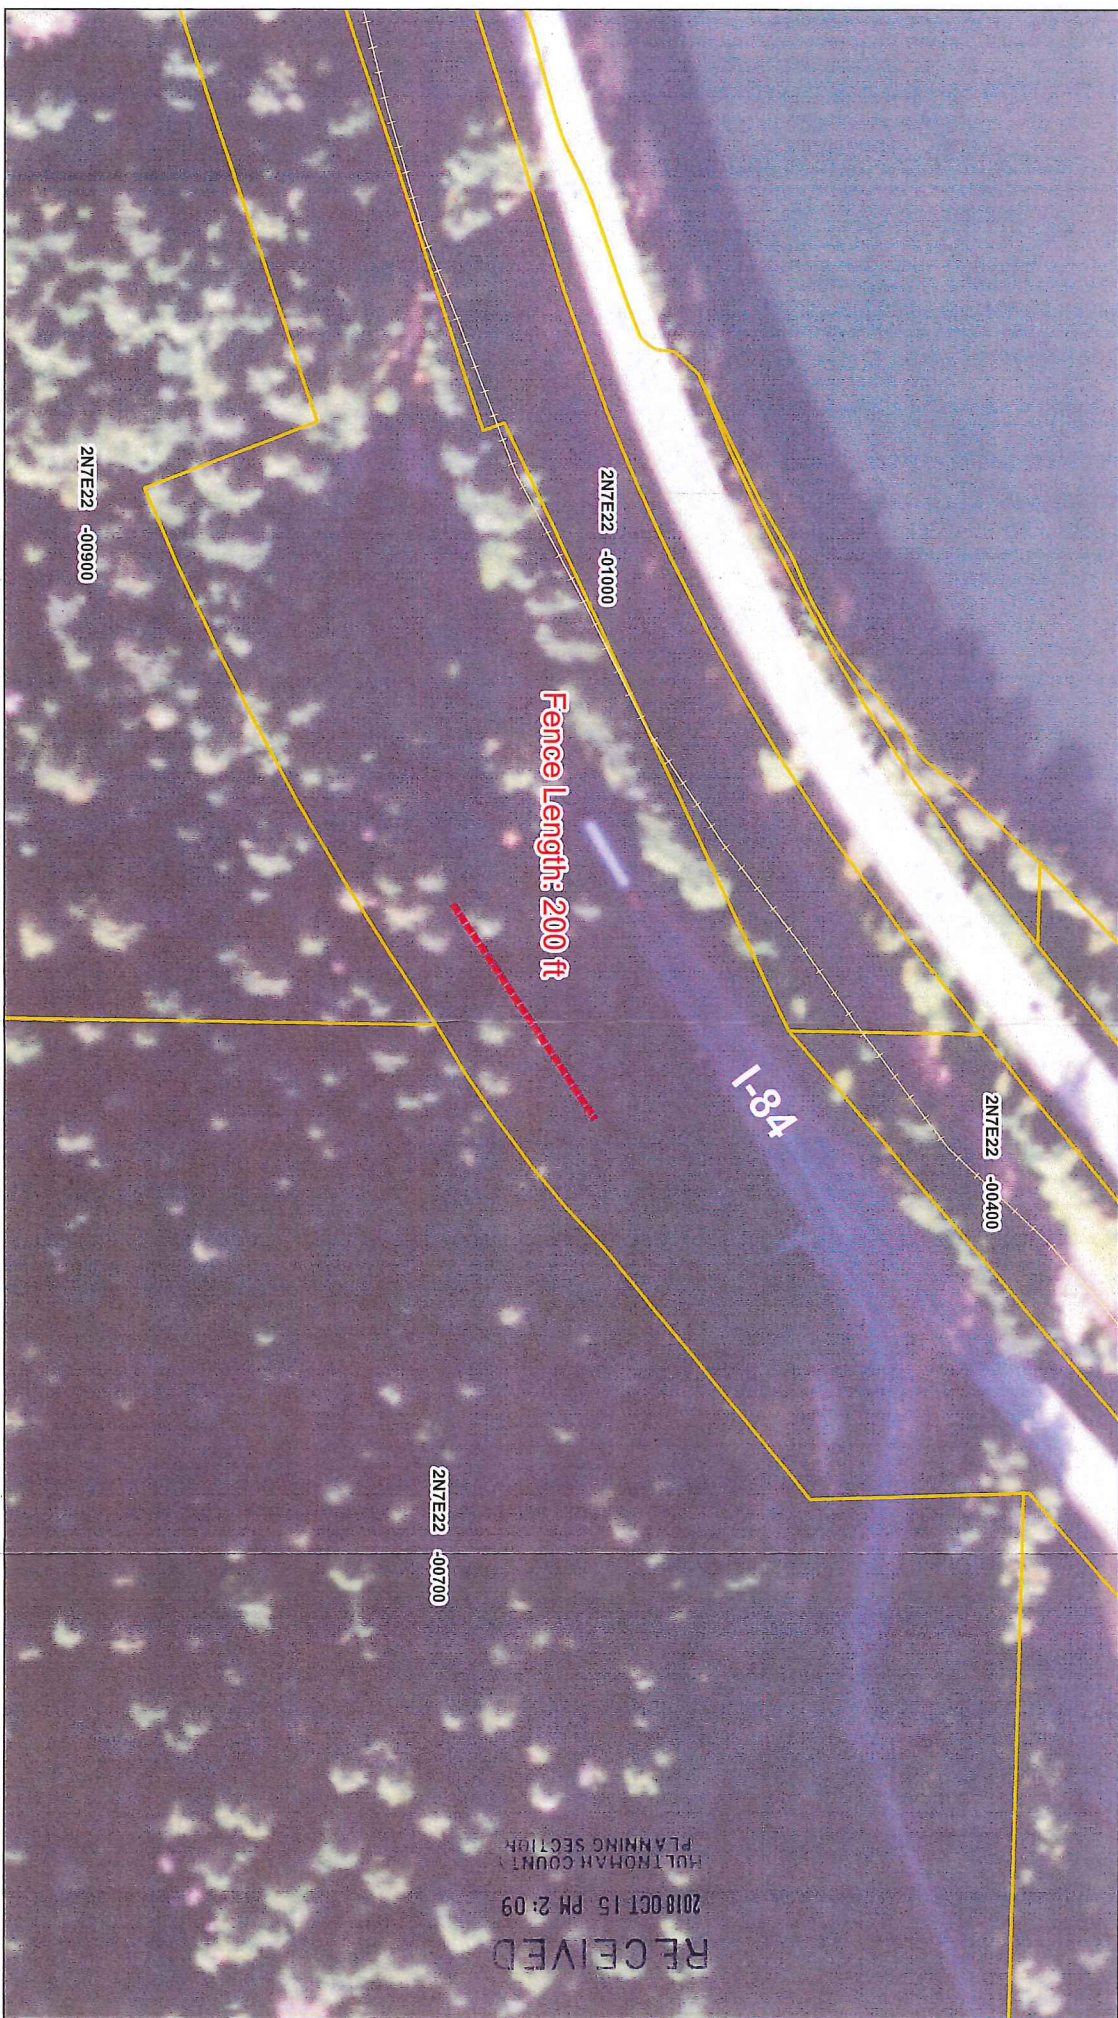
OREGON DEPARTMENT OF TRANSPORTATION
Eagle Creek Fire Response
Toothrock East Fencing Area
Project Site

- Railroads
- Taxlots
- New Fence

Sections of trees on the trail approach to the west side of Toothrock viaduct burned and were removed as hazards between the Historic Highway State Trail and I-84. These trees were providing physical separation between the trail and I-84. Since they are no longer in place, ODOT needs to provide a physical separation for trail users from a steep slope, and ultimately I-84 at approximately MP 27.6 and 27.8. ODOT will add two sections of new brown wooden post and brown mesh fencing, consistent with the *Historic Columbia River Highway State Trail Guidelines (2011)* for trail user safety at this location. At milepost 27.6 ODOT will add 450 feet of new fencing, and at milepost 27.8, ODOT will add 145 feet of new fencing.

On the east side of the Toothrock Viaduct trail approach, existing white two-rail guardrail and adjacent trees burned and had to be removed. ODOT will replace the burned guardrail and construct a 350 foot guardrail extension to the east for trail user safety at this location.
