**HILLSIDE DEVELOPMENT PERMIT (HDP) APPLICATION:  
GEOTECHNICAL RECONNAISSANCE AND STABILITY  
PRELIMINARY STUDY**

**Site Address:** 40301 East Larch Mountain Road, Corbett, OR 97019

Project Description: Renovation of fire damaged View Point Inn to become a spa/retreat facility.

At your request, GRI completed a geotechnical investigation for the proposed View Point Inn renovations and basement construction in Corbett, Oregon. The Vicinity Map, Figure 1, shows the general location of the site. The purpose of our investigation was to evaluate subsurface conditions at the site and develop geotechnical conclusions and recommendations for design and construction of the renovation. The investigation included a review of available geologic information for the site, subsurface explorations and geologic reconnaissance, laboratory testing, and engineering analyses. This report describes the work accomplished and provides our conclusions and recommendations regarding earthwork and site preparation, foundation and floor support, lateral earth pressures, drainage, utilities, and seismic design considerations.

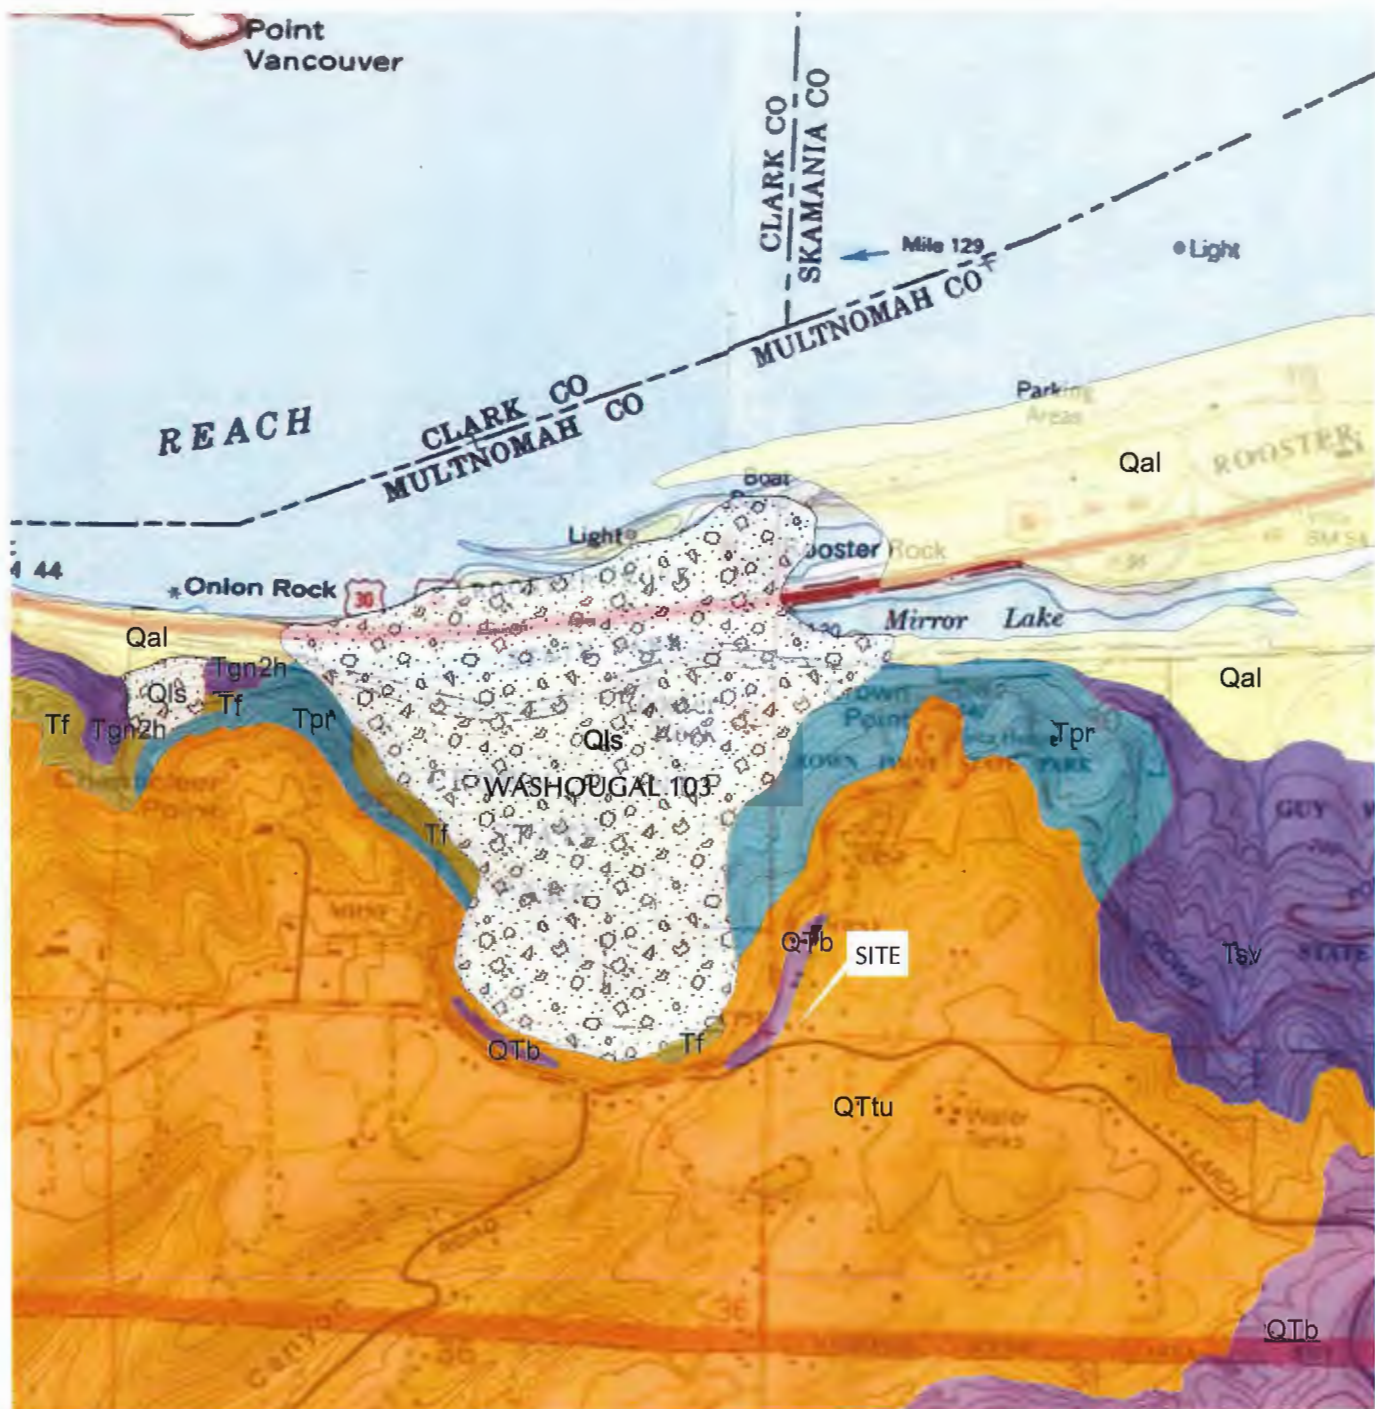
## GEOLOGIC MAP

- Tsv - Skamania Volcanic Series
- Tpr - Columbia River Basalt Group, Priest Rapids Member
- Tgn2h - Columbia River Basalt, Grande Ronde
- Tf - Columbia River Basalt, Frenchman Springs Member
- Qls - Landslides
- Qal - Alluvium
- QTtu - Troutdale Formation, Upper Member
- QTb - Boring Lavas

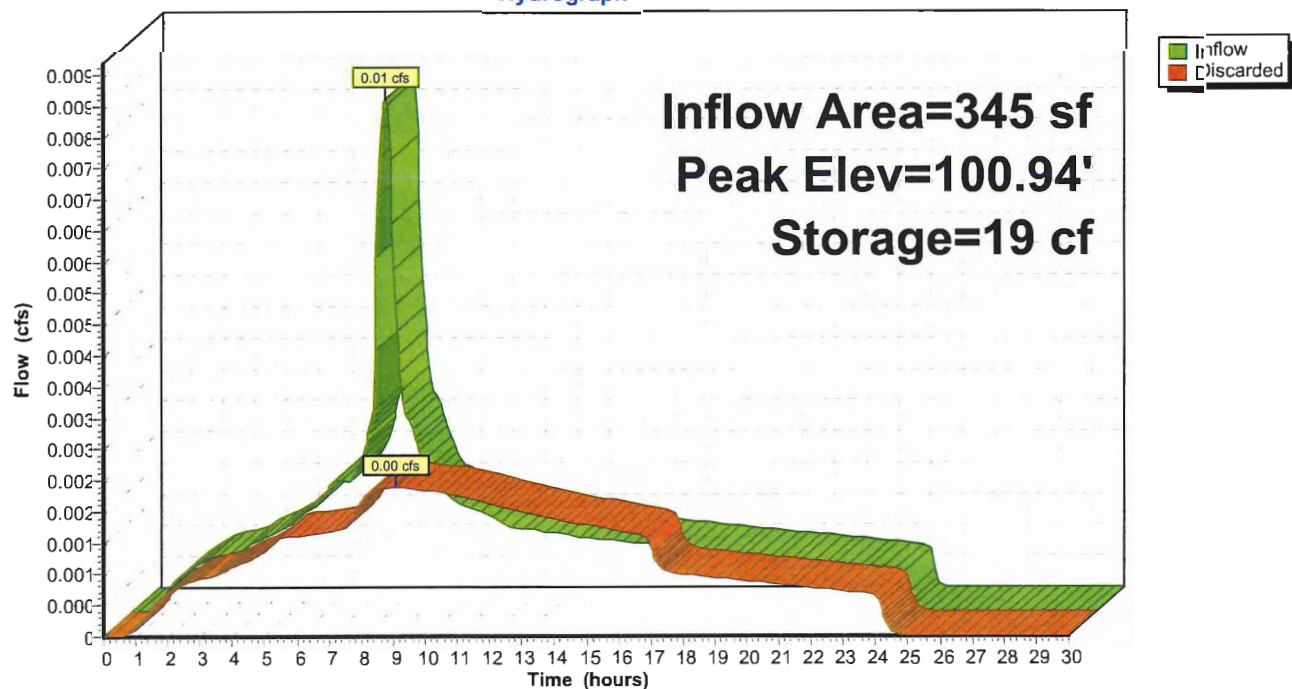
Hydrograph

### Pond 2P: Drywells
