Multnomah County Willamette River Bridges Capital Improvement Plan (2015-2034)

DRAFT for Public Comment

Multnomah County Department of Community Services
Bridge Division
1403 SE Water Ave.
Portland, OR 97214
503 988-3757
www.multco.us/bridges

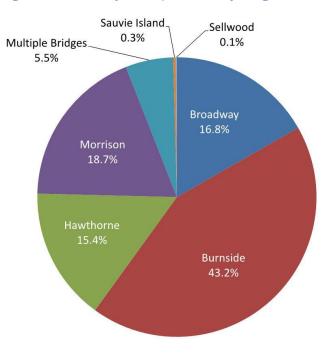
Figure 4 - Summary of Project Costs by Bridge Complex

Bundled projects from the prioritized list have been filtered according to the bridge complex name (Broadway, Burnside, Hawthorne, Morrison, Sauvie Island and Sellwood). There is also a category for bundled projects that incorporate multiple bridge complexes into a single project. The results for the anticipated total cost for each bridge complex, as well as for the project bundles that incorporate multiple bridge complexes, are shown below in **Table 5** and the **Figure 4**. More detailed cost summary tables can be found in **Attachment D**.

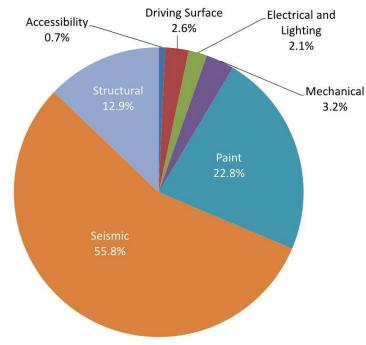
Figure 5 - Summary of Bridge CIP Costs by Primary Work Category

Project bundles from the prioritized list have been filtered according to their primary work category (accessibility, driving surface, electrical and lighting, mechanical, paint, seismic and structural), as shown in below in **Table 6** and **Figure 5**. For bundled projects, the primary work category is the category with the highest percentage of the initial constructed value of the project. More detailed cost summary tables can be found in **Attachment E**.

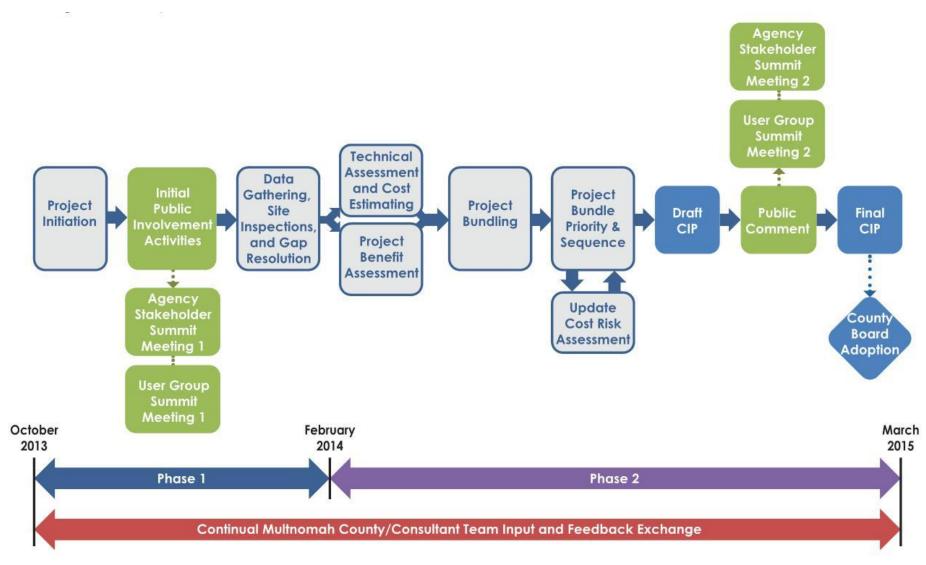
Figure 6 - Bridge CIP Development Process

The process for developing the Bridge CIP is shown in Figure 6.

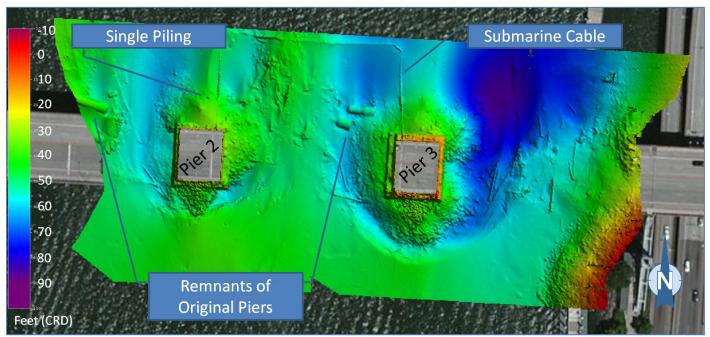
Figure 7 - Burnside Bridge Surrounding Conditions from Hydrographic Investigation

In-water piers and river bottom surfaces were observed through a hydrographic investigation that utilized high resolution multibeam sonar and 3D scanning sonar. These hydrographic technologies allowed the condition of the concrete components of the piers below the waterline to be assessed. They also allowed identification of areas of potential undermining of the existing pier foundations and concrete degradation of the exposed portions of the piers. River bottom surface elevation data collected in 2014 for this project was compared to charting survey data collected for the National Oceanic and Atmospheric Administration (NOAA) in observed features. A sample of the river bottom scan with several submerged features is shown in **Figure 7**.

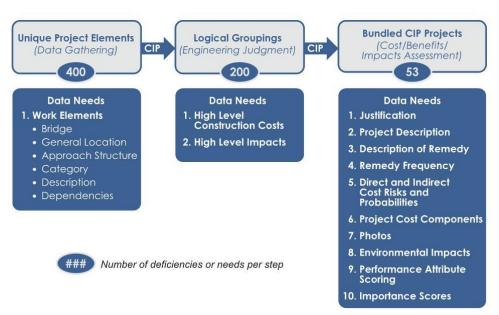
Figure 9 - Project Bundle Development Approach

Based on Bridge CIP objectives, a process was developed to comprehensively evaluate potential deficiencies and needs for each of the County's six Willamette River bridges. Following this evaluation, a systematic approach was implemented to combine the needs and deficiencies into Bridge CIP project bundles, as shown in **Figure 9**.

An initial assessment of all bridges identified approximately 400 potential needs or deficiencies. Based on these needs and deficiencies, 200 Logical Groupings were formed to develop remedies, each exceeding a \$50,000 minimum cost threshold. Engineering judgment was used to bundle individual projects that could logically be completed as a single larger project, to maximize efficiency and reduce costs for mobilization and traffic control. These groupings were then compiled into 53 capital projects (bundles), of at least \$500,000, based on urgency, technical dependencies, proximity, and cost efficiencies.
