Re: Review of Environmental Reports for 2124 N. Williams Property, Portland, Oregon

REMEDIAL INVESTIGATION FINAL REPORT WAGSTAFF BATTERY MANUFACTURING CO. PORTLAND, OREGON

December 10, 1997Project No. 18572

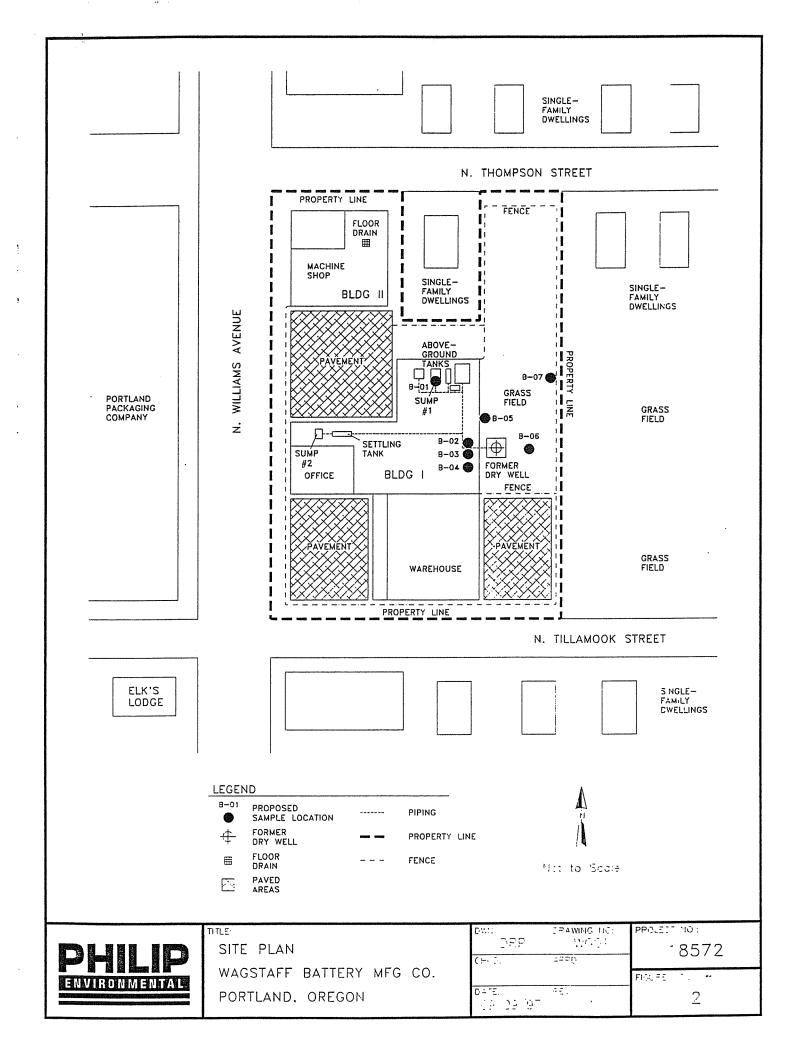
During the period that batteries were manufactured at the site, wastewater from the manufacturing process was pumped to a collection sump in Building I (Figure 2) where lead oxide was allowed to settle out. The water was then pumped into a 3-foot diameter dry-well, formerly located outside the east wall of Building I. The former dry-well extended 18 feet bgs and was set in drain rock.

Three soil samples were collected on October 14 1997 to assess total lead concentrations in the grass lot located on the eastern portion of the Wagstaff property (Figure 2). One sample (B-05) was collected from the area adjacent to the discharge fan; another sample (B-06) was collected along the eastern fence line near the area sampled in 1986; the third sample (B-07) was collected approximately 5 ft east of the former dry-well. Each of the three samples were collected from undisturbed surface soils at depths of approximately 1 to 2 inches bgs. No evidence of previous excavation or other land reworking activities were observed in the sampling locations.

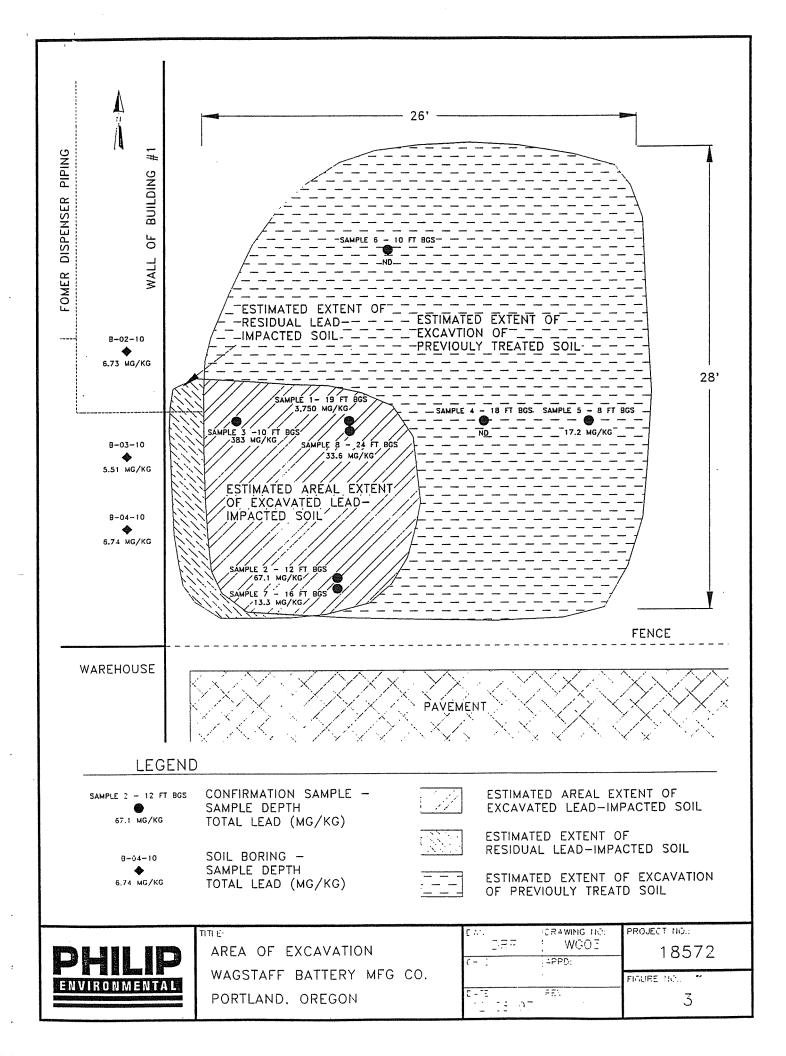
In addition to the previously treated soil, a gray colored soil layer, corresponding to the gray layer identified during the 1993 excavation activities, was encountered in the southwest corner of the excavation pit (Figure 3). The gray layer was observed extending from a depth of approximately 8 feet bgs to approximately 18 feet bgs. The gray layer appears to emanate from the location of the former dry well near the center of the excavation towards the southwest corner of the excavation and the facility building. Along the west wall of the excavation, the width of the gray layer varied from approximately 2 feet at 8 feet bgs to approximately 12 feet at 18 feet bgs.

The vertical extent of the gray layer in the west wall could not be determined due to the proximity of the excavation pit to the foundation of the building and the potential for impacting the structural integrity of the building. However, confirmation samples collected from the bottom of the excavation, approximately 24 ft bgs contained total lead concentrations of 33 mg/kg (Table 2), indicating that the vertical extent of lead-impacted soil did not extend below this depth.

The gray layer was also present, although to a lesser extent, at approximately 14 ft bgs along the south wall, near the southwestern corner of the excavation. The lateral extent of the gray layer along the south wall could not be fully delineated due to the presence of an asphalt driveway, however confirmation samples collected from 16 ft bgs along the south wall indicated total lead concentrations of approximately 13 mg/kg indicating that lead-impacted soils remaining in this area did not extent below 16 ft bgs.
