BROADWAY BRIDGE RALL WHEEL STUDY

Client: CH2M Hill, Inc.

Owner: Multnomah County, OR

Broadway Bridge Rall Wheel Study

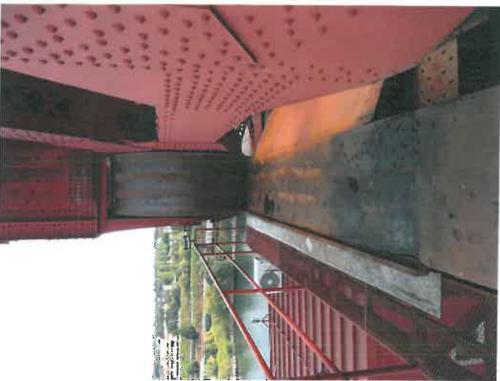
M-001 NW wheel & track

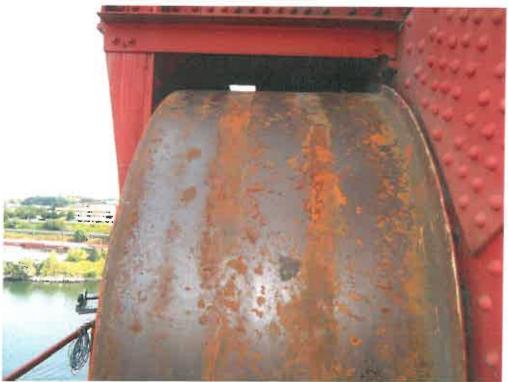
The contact surfaces of the wheels had some rusting, pitting and spalling (See photos M-002 & M-003). Several cored holes were observed. One cored hole was made through a crack in the surface (See photo M-004 & M-005). There was also a group of four cored holes at the upper left corner of the wheel (See photo M-006). On the wheel the visible signs of material differences were observed. These were generally surfaces areas that are inbetween areas where the wheel webs are. It was also observed that there are some areas where the material appeared to have lapped over. Most likely these are the areas where wheel repairs have been performed in the past (See photos M-007 through M-010). Two other cored holes were observed on the lower portion of the wheel surface (See M-011). A straight edge was placed across the width of a sample location of the wheel. The surface was found to be worn and wavy (See photos M-012 & M-013). The wheel rim was previously damaged and weld repaired (See photo M-022). During a bridge operation the wheel contact surface and rim/rim repair was observed (See photos M-015 & M-016).

M-002 NW wheel upper portion

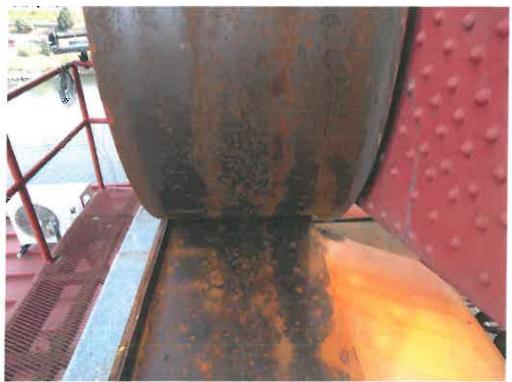
M-003 NW wheel lower portion

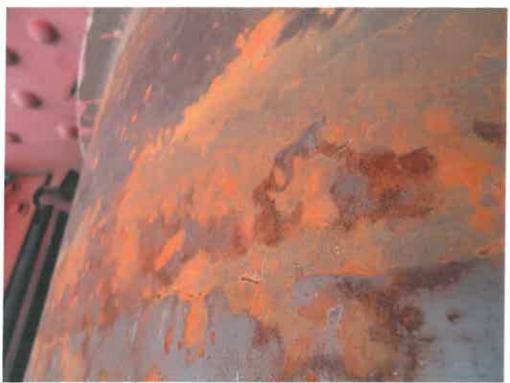
M-007 NW wheel defect

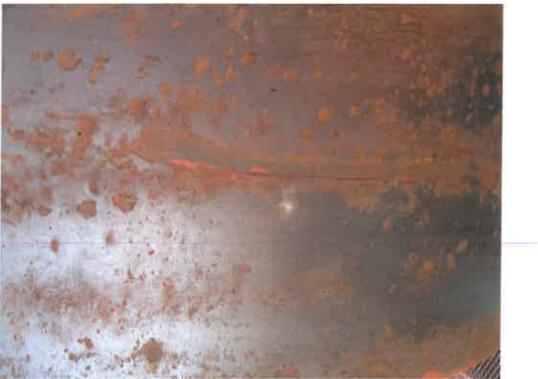
M-008 NW wheel defect

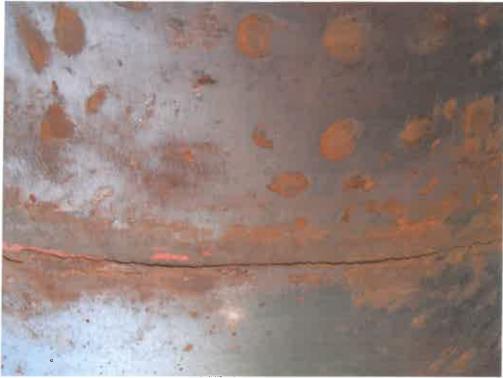
M-009 NW wheel defect

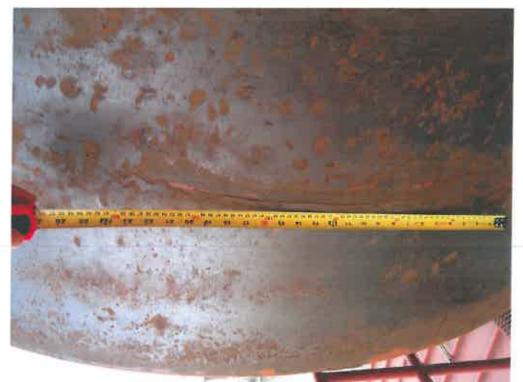
M-010 NW wheel defect

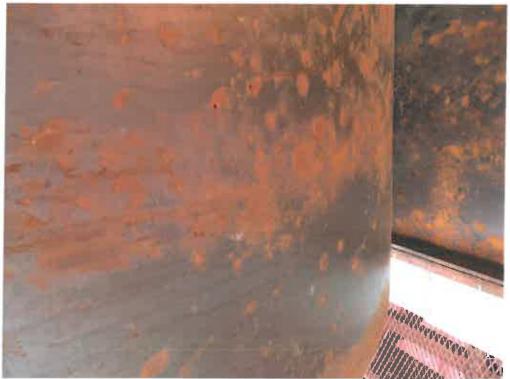
M-011 NW wheel defect

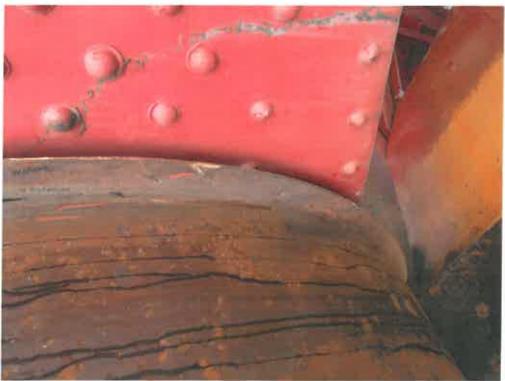
M-014 NW wheel rim defect

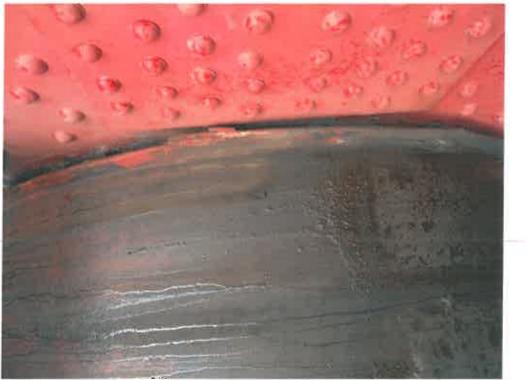
M-016 NW wheel rim defect (bridge open)

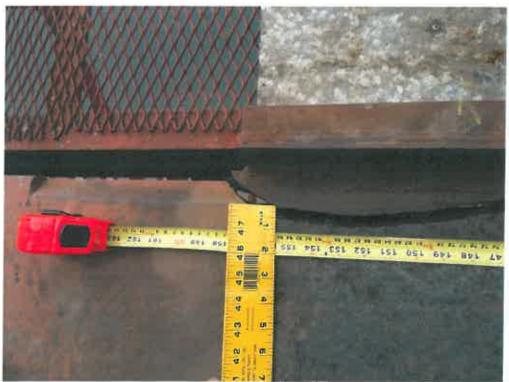
pressure/rubbing against the rail during operation. The majority (approximately 13ft of the total 17ft length of rail) of the weld that connected the rail to the track is cracked (See photos M-019 through M-022). It is noted that the wheel does not contact the rail during the initial travel from the closed position. The portion of track where the wheel sits when the bridge is in the closed position was observed during a bridge operation. No usual observations were noted (See photo M-023).

M-022 NW track defect

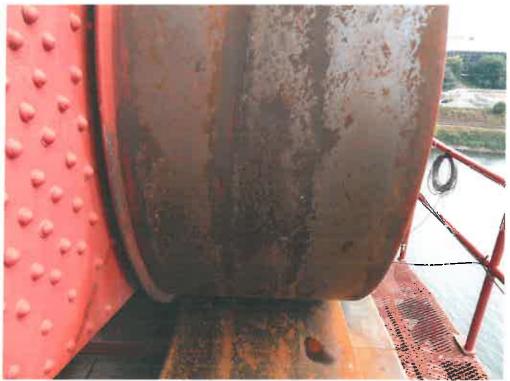
M-027 SW wheel lower portion

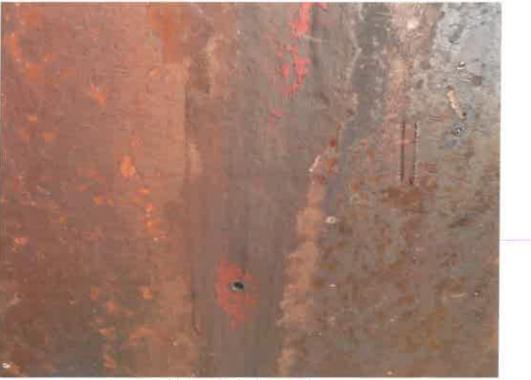
M-028 SW wheel defect

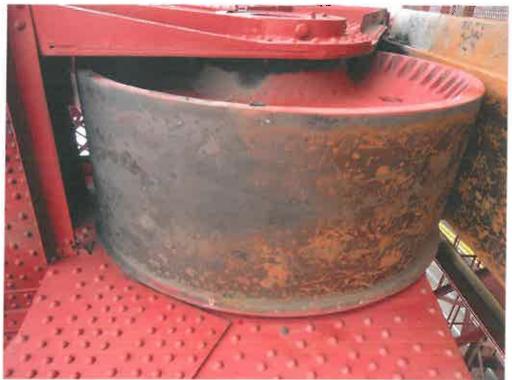
M-041 NE wheel (bridge open)

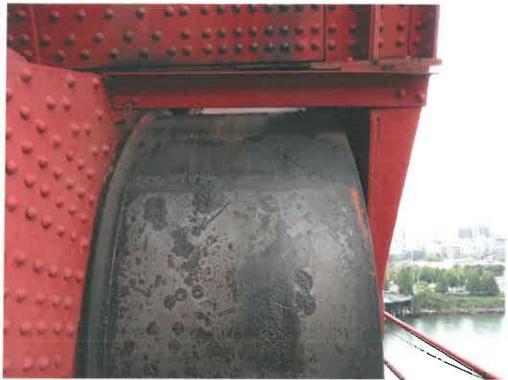
M-043 NE wheel (bridge open)

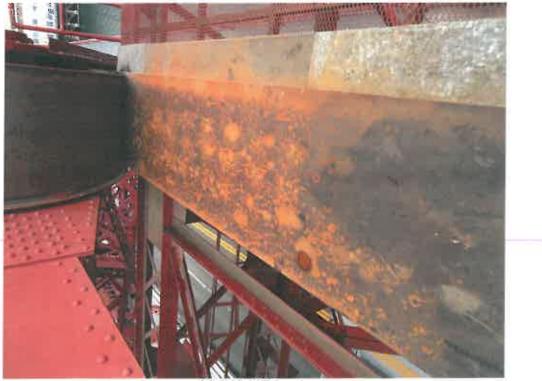
M-046 NE track

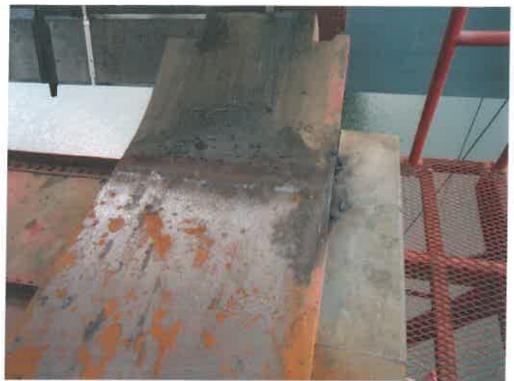
M-047 NE track (bridge open)

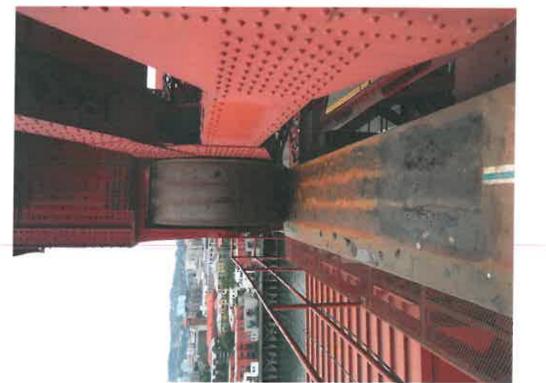
M-048 SE wheel & track

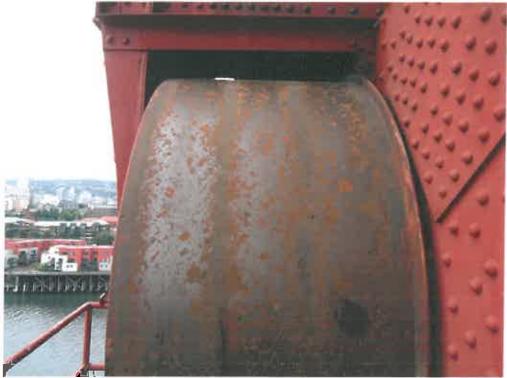
M-049 SE wheel upper portion

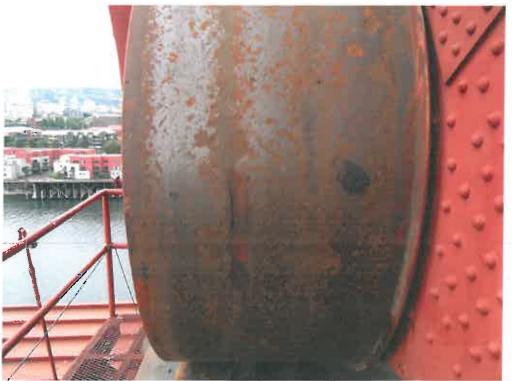
M-050 SE wheel lower portion

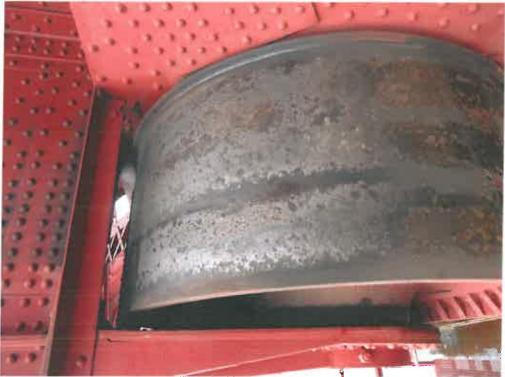
M-053 SE wheel (bridge open)

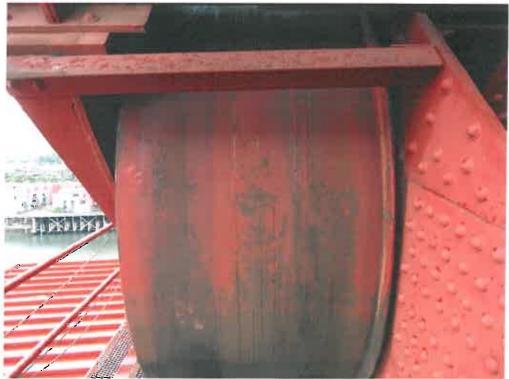
M-054 SE wheel (bridge open)

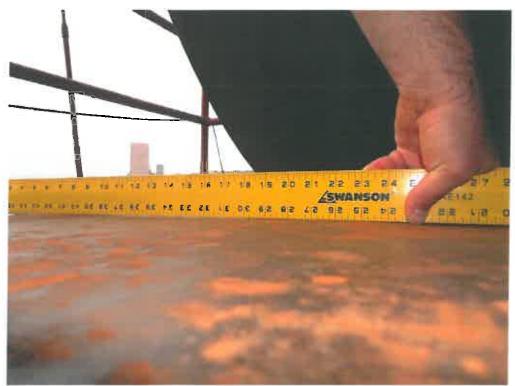
M-057 SE track

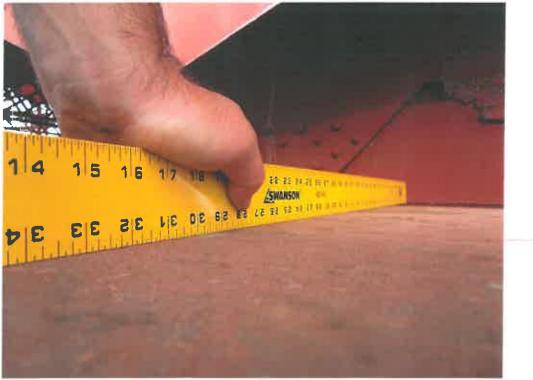
M-058 SE unused track

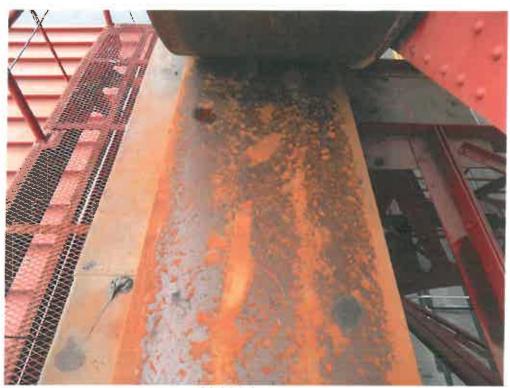
M-061 SE track

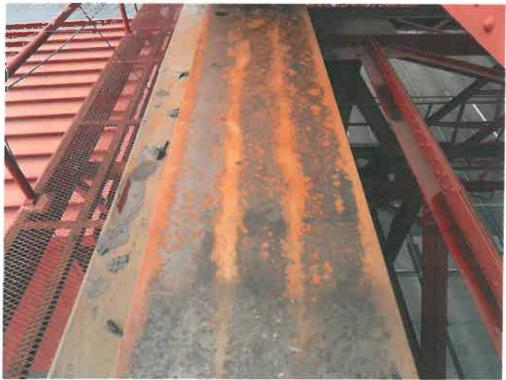
M-062 SE track

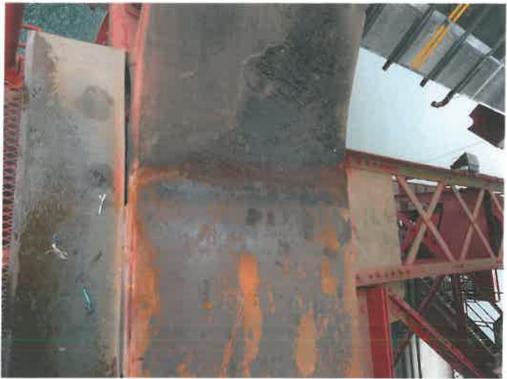
M-063 SE track (bridge open)
